## Managing Investigations in the Urgent Phase Following Railway Accidents

A. Bracciali<sup>1</sup> and M. Monti<sup>2</sup>

### Abstract

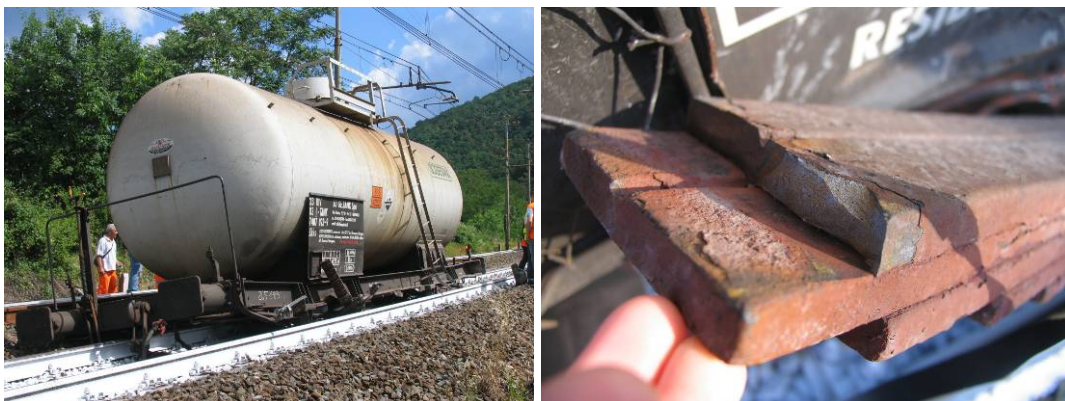
The train stopped after having destroyed more than 4 km of track but luckily the tank did not break holding the very dangerous chemical product. After a short survey, the reason for the accident was discovered in the front left suspension of the tank, that showed evident signs of a fatigue failure of the main leaf near the eye mount. The fracture surface showed a smooth and bright surface where the fatigue crack progressed probably since long time, extending approximately for 40% of the total cross section of the leaf, while the remaining part of the surface was rough and irregular. As often in the case of fatigue failures, the sudden lack of useful section led to a brittle fracture, enhanced by the typical behaviour of steels for spring which have a relatively low (if not none) plastic elongation after tensile testing.

Figure 1 shows a picture of the derailed wagon (other vehicles were involved in the accident) and a close-up on the broken leaf spring. In this case the restoration of the railway line could have started immediately after the discovery of the fatigue-fractured element: no single element in the line can produce such a failures, as it results from a long story which is not related to the events that happened in the last moments of travel before the accident.

Figure 1: Railway tank derailed (left) after failure in the front left leaf spring (detailed right). Fatigue and sudden broken surfaces are clearly distinguishable.

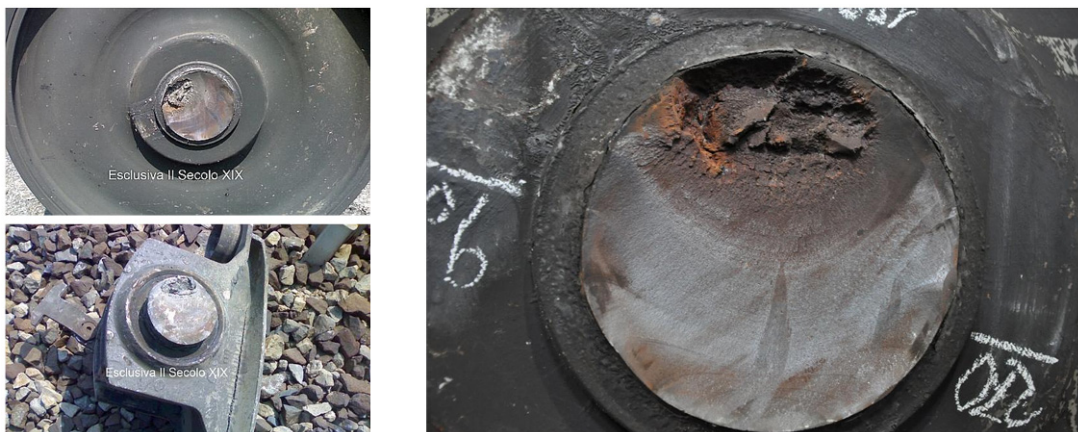
Newspapers reported the day after the accident some pictures taken on the scene were a broken axle was found split in two parts, one still belonging to the wheelset and the other remained in the axlebox (Figure 2). Deeper investigations after the accident confirmed that the root cause of the accident was the broken axle whose fracture surface exactly shows all the features of a shaft subjected to rotating bending under a moderate-to-low average load.

Also in this case the root cause of the accident appears clear. The attention of the investigators focused in fact on the tracks that the tank hit *after* the derailment and *not before*, meaning that there is a general consensus that the track *before* the point where the accident started has no relevance in the accident. The first author was involved in the past years in the trial dealing with ultrasonic inspections but he is not involved anymore in this accident.

Figure 2: Axle broken in Viareggio as reported by the newspapers (left) and pictured during investigations after the accident (right).

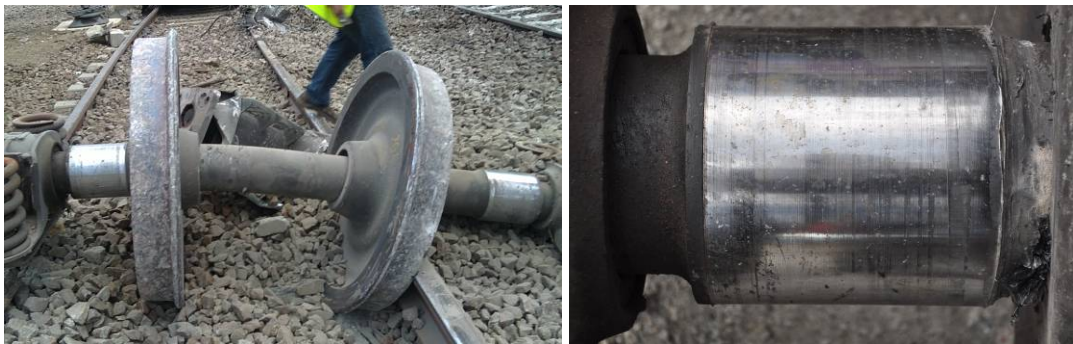
The first wheelset was found with both the wheels displaced from the seats while the fourth wheelset had only one of the wheels displaced (Figure 3). Quite surprisingly, the aspect of the wheelseat surfaces were found without any defects, meaning that probably the displacements of the wheels was not due to a sudden condition (such as an abnormal braking or an exceptional force encountered during the service) but resulted from an abnormal mounting condition that had no relation neither with the track nor to the actual service.

Figure 3: Displaced wheels from the wheelset on the first wheelset of the wagon (left). Aspect of the surface after wheel displacement revealed no defects or damages typical of wheels pressing off (right).

Also in this case the reason for the accident was the vehicle and the infrastructure had clearly no responsibilities in what happened. This was later confirmed by the investigations that showed how the tolerances that had to result in a firm press-fit of the wheel over the axle were not observed.

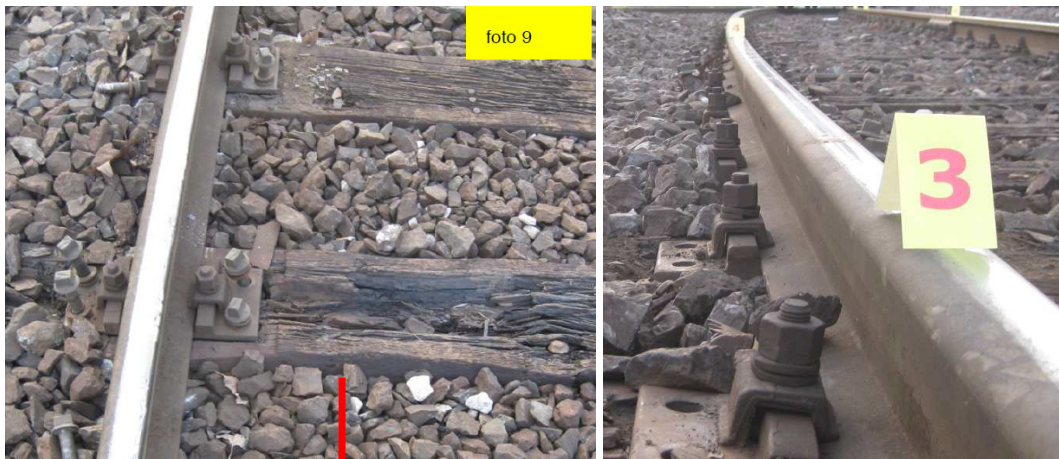
A locomotive derailed at low speed during shunting in a curve after a turnout. The rail is fastened to the sleepers via steel baseplates, coach-screws and K-fastening as shown in Figure 4 and in Figure 5. The investigators found that the wooden sleepers were old and deeply damaged; many coach-screws were missing resulting in an exceptionally laterally flexible rail that displaced under the action of the locomotive.

Figure 4: Aged conditions of wooden sleepers on the turnout in Chiasso responsible for the derailment of a locomotive.

After the running conditions of the locomotive (speed) were checked, the locomotive has been removed and the track restored. A following check of the running gear dimensions in the local workshop confirmed the investigator's intuition, i.e. the fact that the track was the responsible for the derailment and that the locomotive was just a victim of a poorly maintained infrastructure.

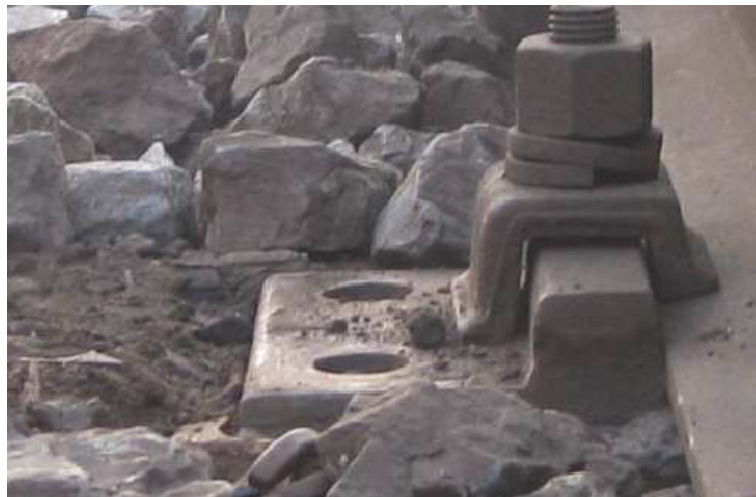
Figure 5: Detail of the baseplate with missing coach screws.
