Paper 312

# Elimination of Failures in Railway Gearboxes by Regenerative Coasting

### A. Bracciali and F. Piccioli Dipartimento di Ingegneria Industriale Università di Firenze, Italy

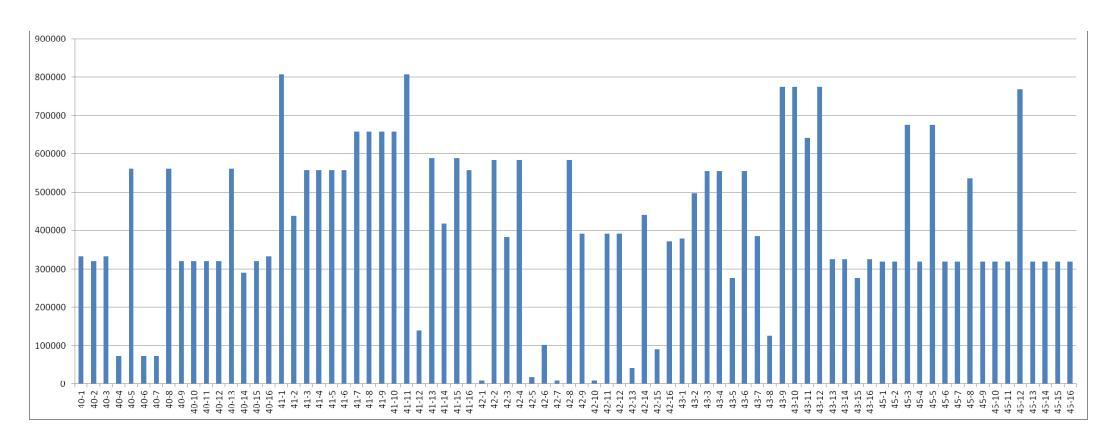
Figure 8: Distance run by each of the 80 gearboxes of the trains running on Line 3 (as of 15.9.2012)

- some gearboxes are still in operations from the original supply even if they ran over 700.000 km, some other are "brand new", in the sense that their bearings were changed quite recently;
- the majority of failures happened between 200.000 and 400.000 km, while the original interval forecasted for general overhaul of the gearbox (when bearings had to be checked) was originally set to 1.2 million km.

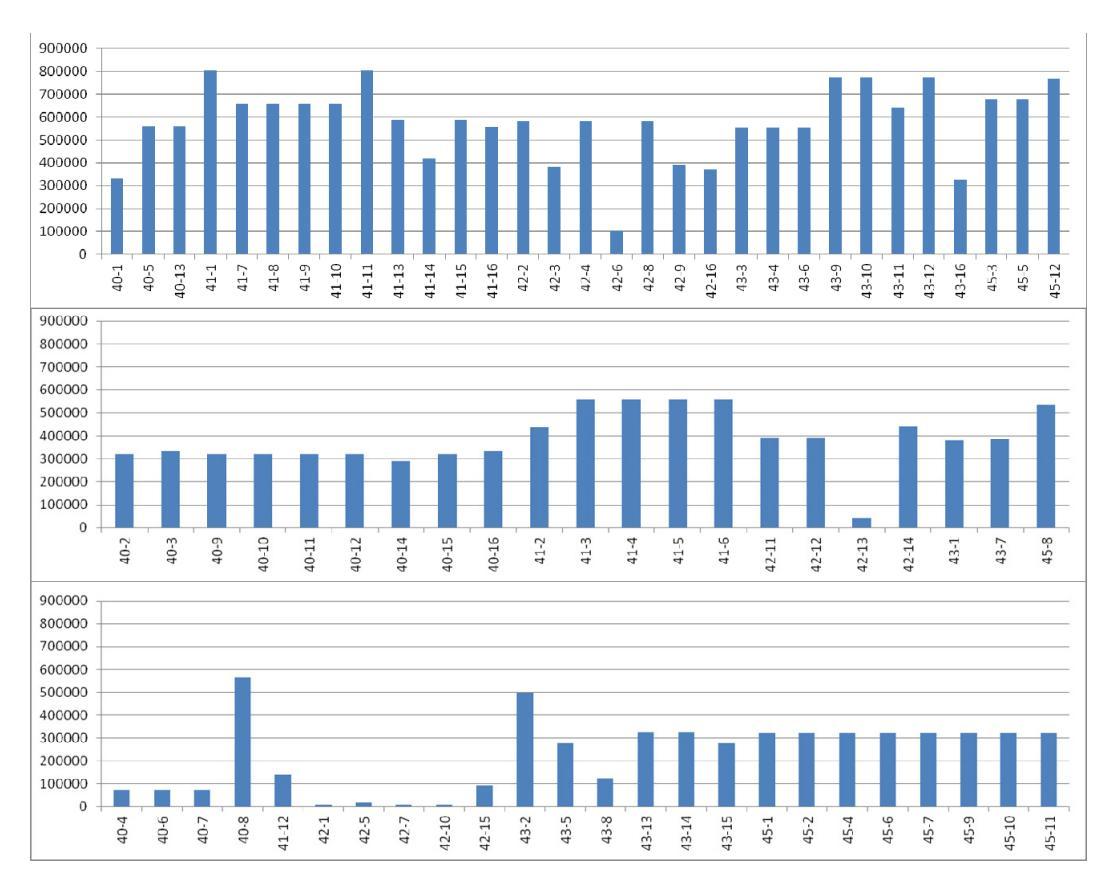
Both these evidences indicate that the problem in subtle and tricky: not all of the bearings of the first supply failed (and when they are still in service they clearly completed the highest run), while just repaired gearboxes are not interesting as they are "new". Figure 9 shows the data aggregated by original bearings, OEM changed bearings, and alternate supplier changed bearings.

Figure 9: Distance run by original (top, 31 gearboxes), retrofitted with OEM bearings (mid, 21 gearboxes) and retrofitted with alternative supplier bearings (bottom, 28 gearboxes) gearboxes as of 15.9.2012 for trains running on Line 3

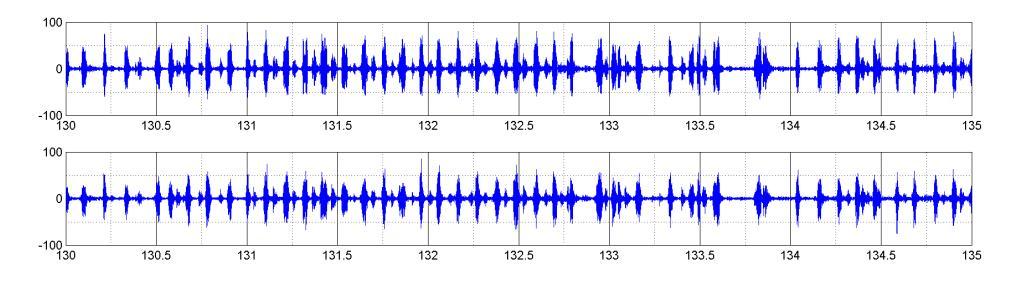
Tests were initially performed on a gearbox that had run approximately 90.000 km with new bearings. The presence of spikes was readily found; these were more present with inverter switched off than with the inverter switched on; an example of spikes found is shown in Figure 12, where very high top levels (up to  $70 \div 80$  g) were found. As long as vertical movements were apparently involved, the joint was disconnected and an excitation with an instrumented hammer was given while the response was measured with an accelerometer mounted near the reaction rod attachment (Figure 13), measuring the point frequency response function (inertance) of the whole gearbox.

Figure 12: Lateral and vertical accelerations recorded on a gearbox in coasting at 80 km/h (gearbox age: 90.000 km)

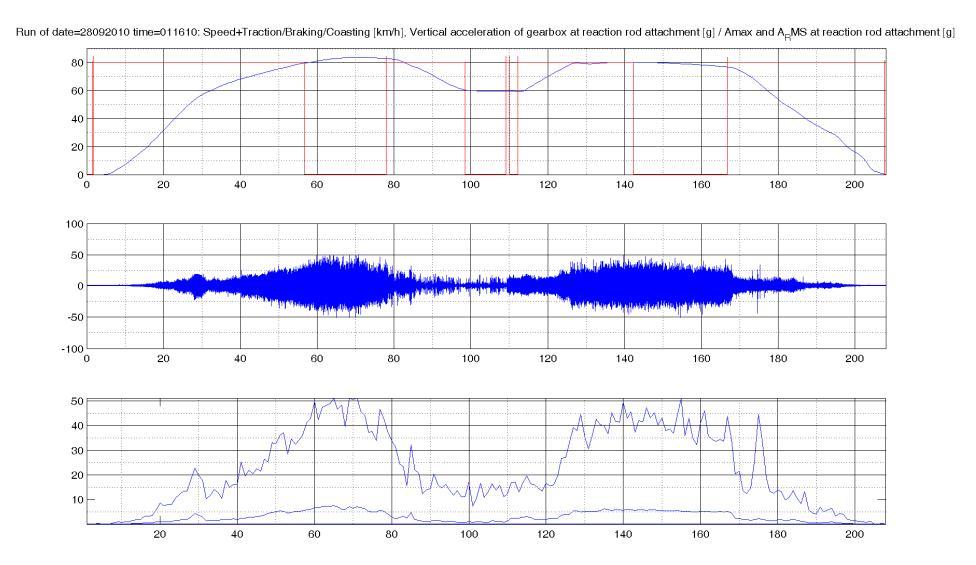
As the importance of gearbox natural frequencies was evident, all the gearboxes of a different train were tested with the impact hammer, leading to the results shown in Figure 17. All the gearbox appeared very similar, leading to the conclusion that the failures were possibly due to the coincidence of the forcing function and the natural frequency of the gearbox (resonance condition). Eight gearboxes of this train were therefore equipped with accelerometers and measured but the data were unusable as *all channels saturated the*  $\pm 50$  *g range*, showing damages in all the gearboxes.

Figure 15: Signals recorded during a full test run. Speed & coasting signal (top), acceleration on the reaction rod (mid), RMS and peak of acceleration (bottom) (1 s interval)

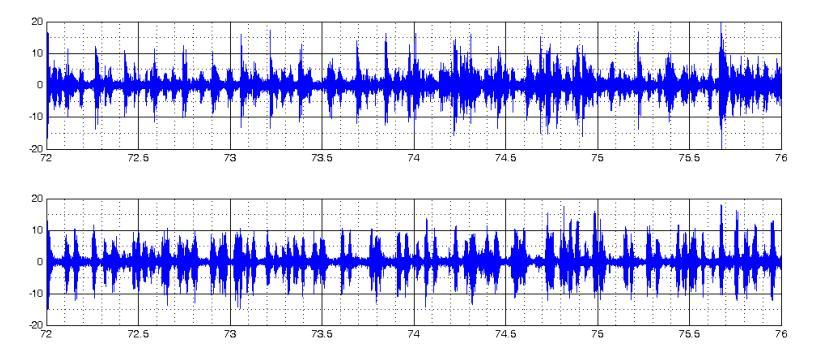
Tests were repeated on a different train and, quite surprisingly, the accelerations did not show any clear relationship between amplitude and frequency with speed and the spikes were again quite erratic (Figure 18). It was therefore concluded that the results found before were only due to a gearbox *that was already damaged* at the time of the measurements. The hypothesis of a root cause due to resonance was therefore discarded: the dynamic system was *tuning itself on the vertical natural frequencies that "drove" the system to oscillate at that frequency and to produce spikes at that frequency*. When the damage was removed, by choosing a different train, that coincidence disappeared. Reversing from traction to braking the torque in the gearboxes, different teeth flanks meshing conditions (see Figure 19) led to clear changes in the average acceleration levels (Figure 20). Different meshing conditions also affected vibrations during coasting (Figure 21).

Figure 18: Erratic acceleration spikes measured near the reaction rod attachment during a run at 60 km/h in January 2011. No clear relationship with speed was found

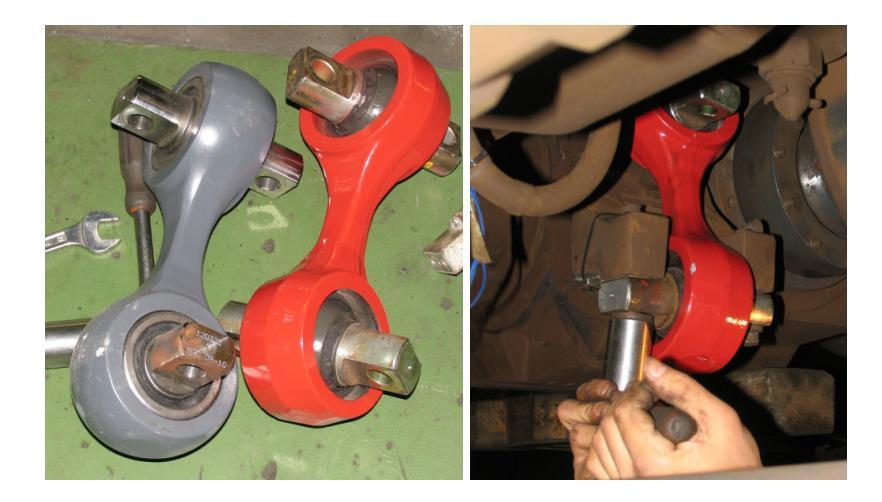
The attempt to install a modified reaction rod including all-steel spherical joints (Figure 23) failed due to too high play inside the joints that are very stiff but that cannot be effectively adjusted (or preloaded) in this application. Nevertheless, the use of a different rubber (without play) element should be considered carefully in case of retrofit of the gearbox fleet.

Figure 23: Standard rubber joints (grey) and stiffened all-steel joints (red) reaction rod. No fixed position of the joint is defined as both joints are free to rotate

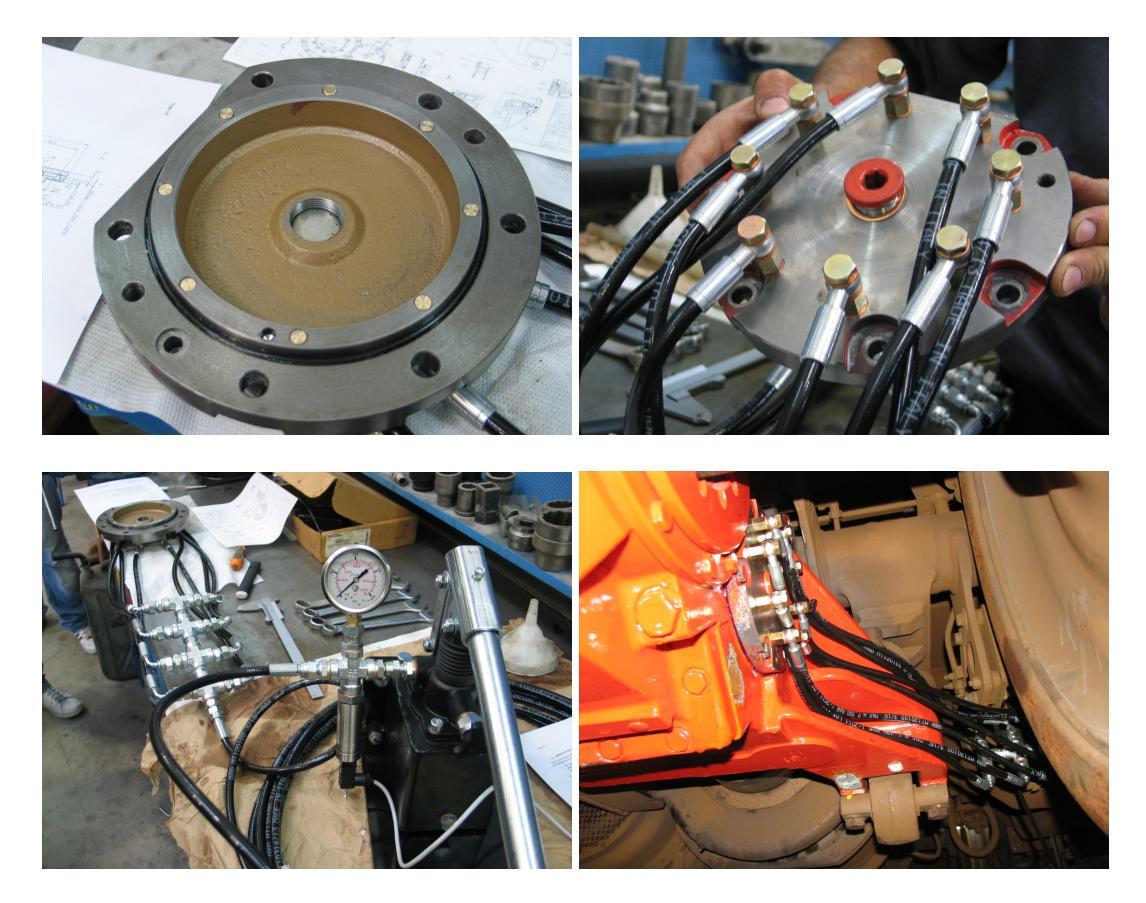
In order to try to reduce variations in the load ("shaking") of the intermediate shaft, an axial preload system was designed and built. By modifying an intermediate shaft cover, eight hydraulic pistons were introduced to give forces on the outer race of the taper bearing (suitably ground to allow its axial movement) of up to almost 10 kN, driven by a hand pump (Figure 24). Pressure was monitored with a pressure gauge and a transducer. Although the equipment proved to be easy to install and perfectly working, no differences were obtained during tests, in the sense that peaks occurrence remained unchanged in terms of randomness and amplitude. This evidence was nevertheless useful as it proves that acting on bearing preload or play leaves the source unaffected. Play can certainly exacerbate the problem but it's not its root cause.

Figure 24: Intermediate shaft cover with 8 hydraulic pistons to push axially the outer race of the taper bearing. Details of the hydraulic pump with pressure gauge and pressure transducer and installation on a gearbox

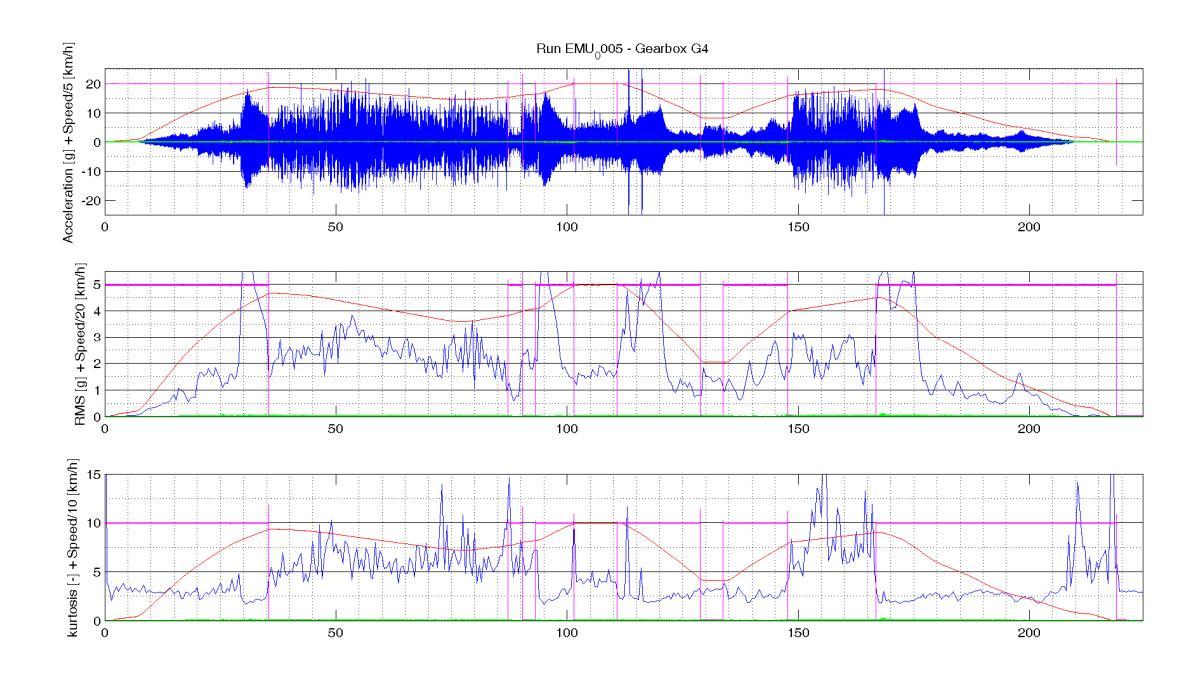
The four gearboxes proved to be in initially very different conditions, showing RMS values quite depending on the speed and direction. As an example, Figure 33 and Figure 34 show the application of a 40% regenerative coasting to the worst gearbox in the set (G4). While RMS levels increase, kurtosis value decrease dramatically, confirming that the solution is valid. If the reader is concerned about the quite high value of the regenerative coasting used, he should look at gearboxes G1, G2 and G3: values of 10% of regenerative coasting are generally sufficient to prevent spikes on initially good gearboxes. Regenerative coasting can certainly fix problems of highly defective gearboxes, but its best use is as a prevention measure to be applied to gearboxes since the beginning of their life, when they are certainly in good conditions.

Figure 33: Gearbox 4 with no regenerative coasting (original traction software). Vertical gearbox acceleration (top), RMS value (mid), kurtosis (bottom). Speed and coasting signals are also indicated

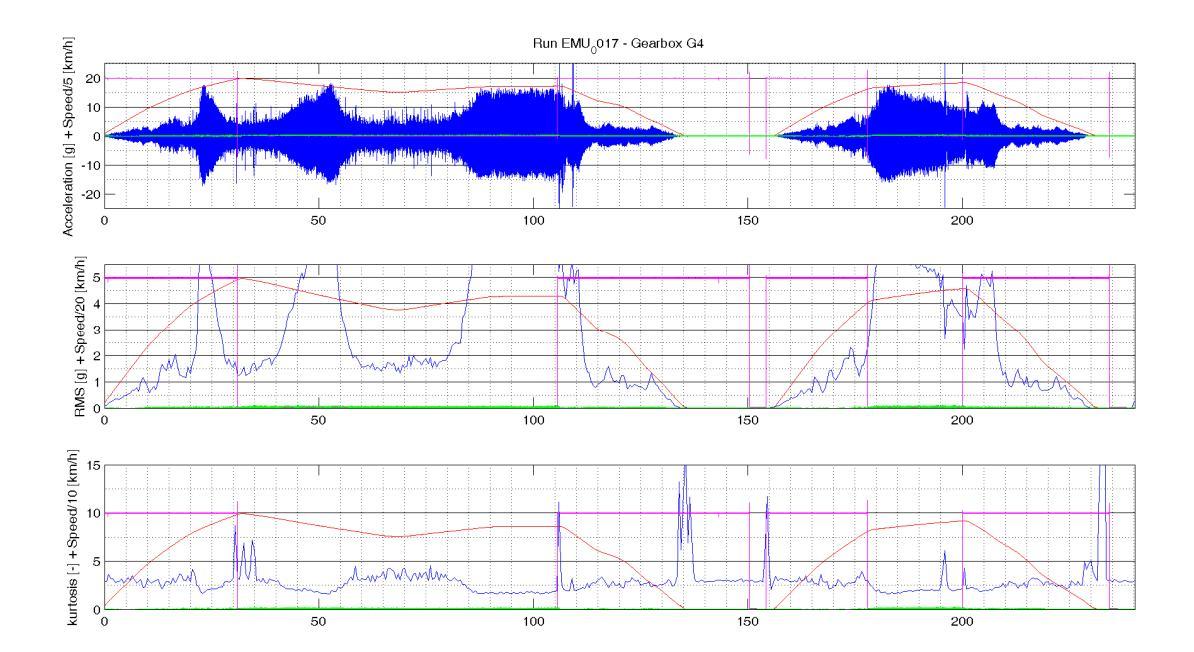
Figure 34: Gearbox 4 with 40% regenerative coasting (modified traction software). Vertical gearbox acceleration (top), RMS value (mid), kurtosis (bottom). Speed and coasting signals are also indicated

The final measure applied, i.e. a torque preload by means of the so-called "regenerative coasting" procedure, completely removed the oscillations ("spikes") that are believed to be the root cause of the failures. A companion paper explains the signal processing procedure that allowed to qualify and to accept the proposed measure as a valid criterion to be applied extensively.
