Roughness growth – A practical case

A. Bracciali

Abstract

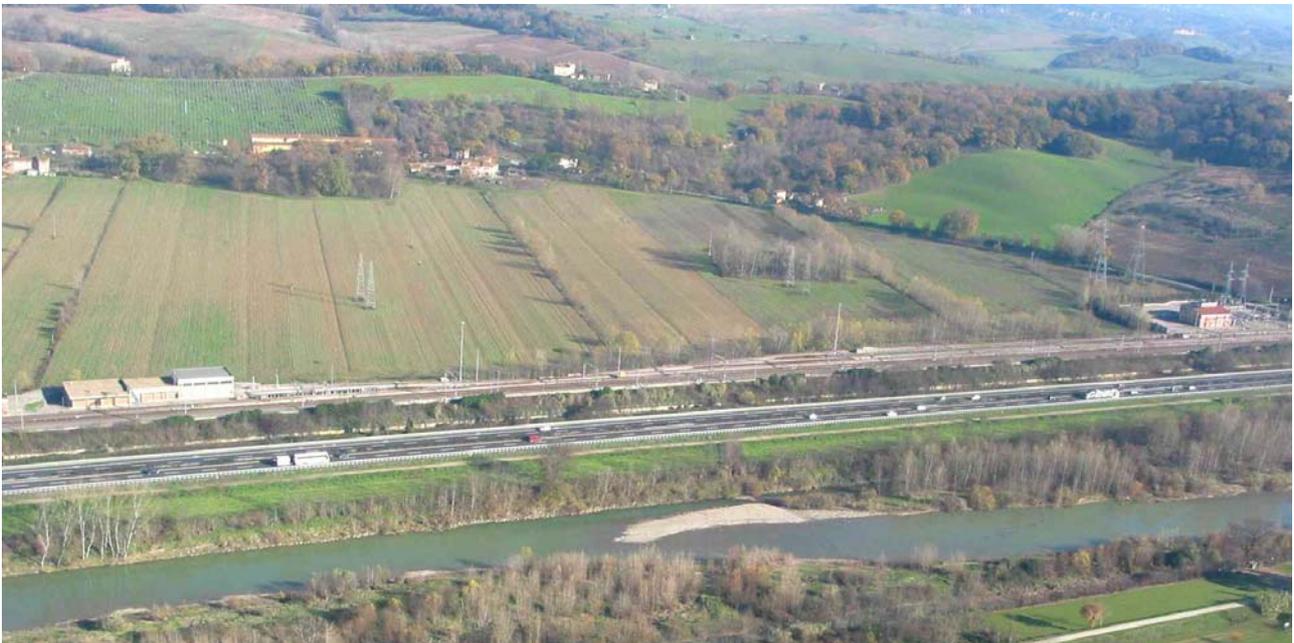
Figure 1. Aerial view of P.C. Renacci (13 December 2003).

An aerial view of P.C. Renacci facing East is shown in Fig. 1. Clearly visible are the river Arno and the Milan-Naples A1 Motorway. North (left) building is P.C. Renacci, where the junction switches are located; South (right) buildings are SSE Renacci (Electric Substation). Noise measurements are normally conducted on the East side of the line, as the presence of the highway in the West side prevents the use of a microphone at 25 m from the track. The author normally prefers a test site close to P.C. Renacci, measuring even-numbered northbound trains, but for the activity shown in this paper the southbound track was considered as the rails were ground on 31 May 2003 almost for the entire extent from P.C. to SSE, starting after the switches. This site was also chosen by RFI (Rete Ferroviaria Italiana, the Italian infrastructure owner) for noise measurements, not related to the activity illustrated here, made on July and on November 2003.

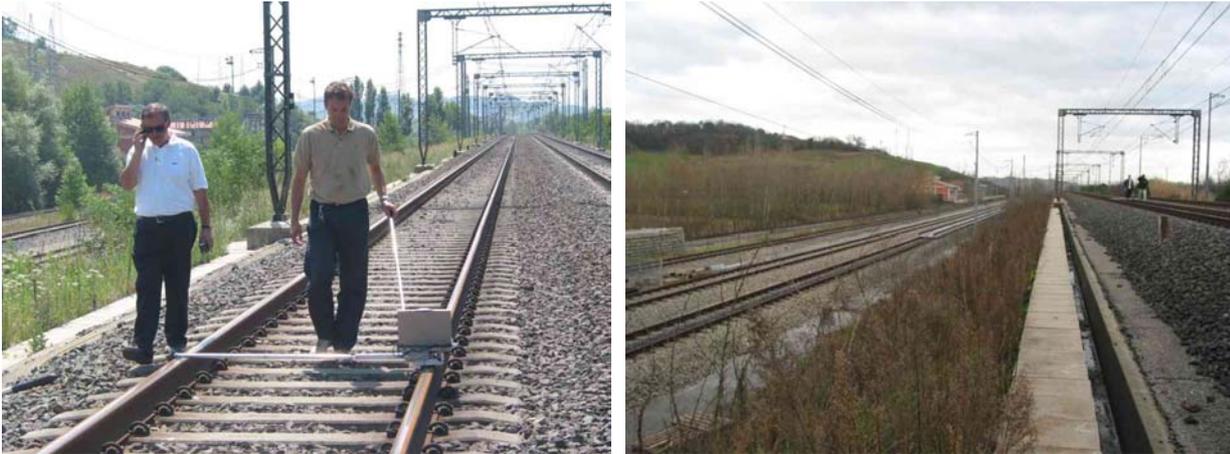
Figure 2. View close to the RFI zero point, looking South towards SSE Renacci on the exceptionally hot 2003 summer (1 July 2003) and a cold cloudy winter dawn (13 January 2004). The much lower level of neighbouring yard tracks is clearly visible.

Roughness measurements were taken on the ground track using as a reference the “zero-point” defined by RFI for its activities. A picture facing South of the area close to the zero point is shown in Fig. 2. It is evident the high steepness of the scarp which, especially at 25 m from the track axis, clearly contrasts with the requirements of the standards (ISO 3095 requires that “the ground needs to be essentially flat and within a level from 0 to -1 m, relative to the top of rail”).

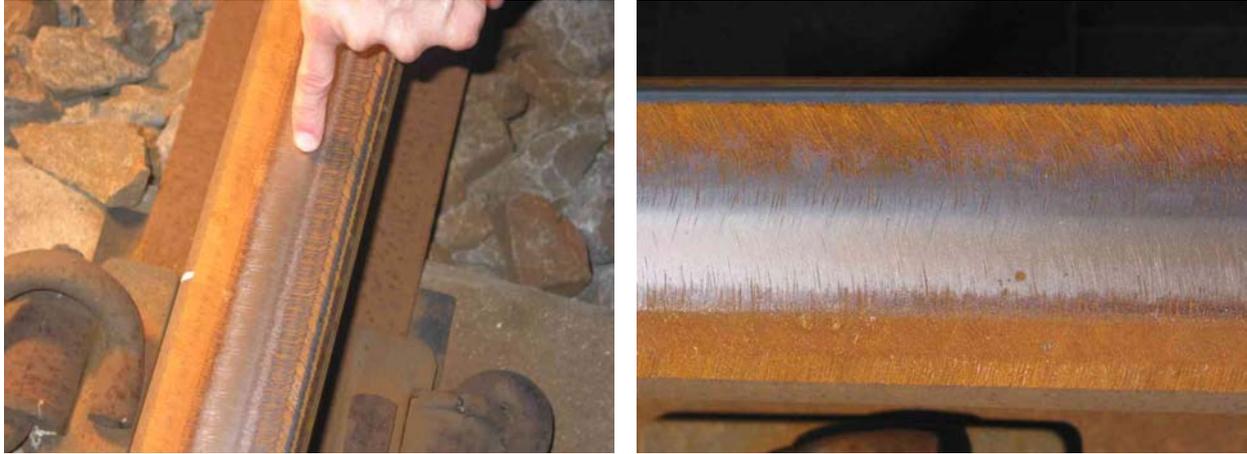
Figure 4. The first photos of the railhead on the left rail (30 June 2003).

Unfortunately it was not possible to attend the grinding operations on 31 May 2003. Figure 4 shows one of the first pictures taken after grinding, where rotating stones grinding marks are clearly visible. The definition of the running band resulted to be quite hard, as it was desired not to measure on the outer portion of the bright stripe where grinding marks were more evident.

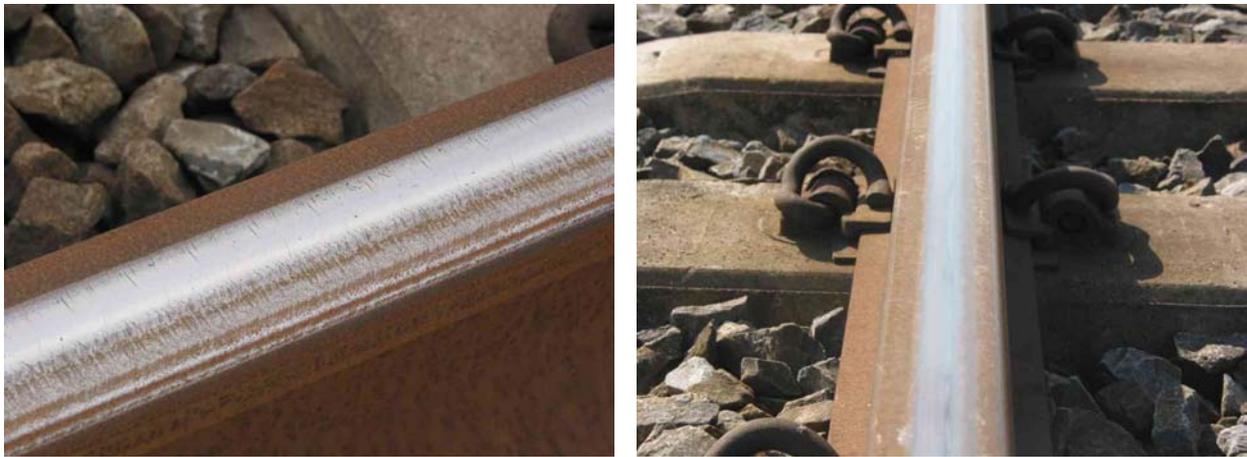
Figure 5. Railhead aspect after six months (left, 4 December 2003) and after one year (right, 14 May 2004).

As a sample, two other photographs are shown in Fig. 5. After six months grinding marks were still evident; only after one year the situation seems normal.

The aspect of the running band changed in time in a very non-uniform way. Italian rails are inclined by 1:20, and the profile coupling with ORE S 1002 wheel leads to a double contact: the contact point passes suddenly from the wheel tread/railhead top position to wheel flange/railhead flange side position, leading to non-uniform wear (and to stability problems at the higher speeds). A situation very different was found by the author in a country where rails are inclined by 1:40 [1].
