RAIL CORRUGATION GROWTH IN A METRO CURVE

Andrea Bracciali

Dipartimento di Meccanica e Tecnologie Industriali
Università degli Studi di Firenze
Via Santa Marta 3
50139 Firenze, Italy

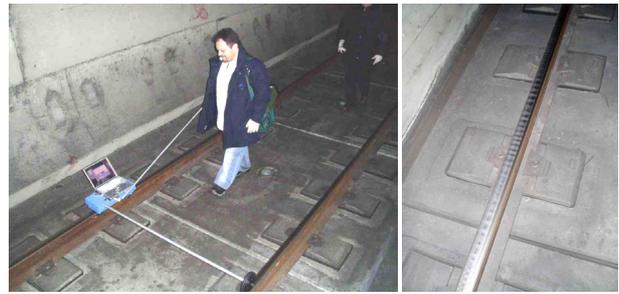
Figure 1. Metronapoli Cilea-Vanvitelli track (left) and an example of heavily corrugated low rail (right).

Figure 1 shows the track during corrugation measurements and a close-up of the rail. Figure 2 shows a sketch of the curve, where some specific locations that will be referenced to throughout the paper are indicated (see also Table 1). Table 2 shows the position of part of the low rail welds, the PK of rail centre and the (average) track geometric properties for each rail.

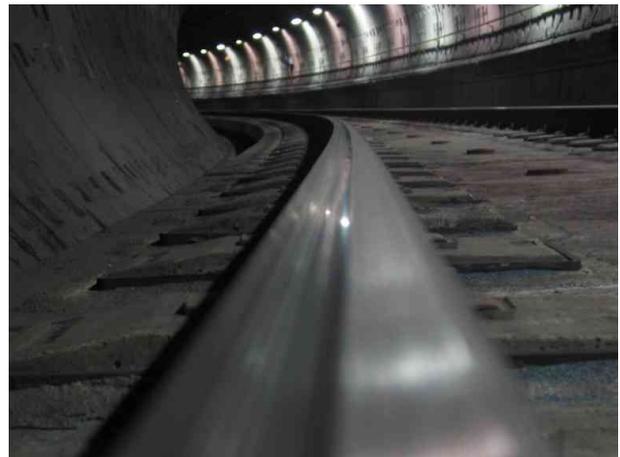
Figure 4. Corrugation in the 30-100 mm wavelength range immediately after last grinding (top). Running band appearance after one day (mid) and relative corrugation (bottom).

It is worth to mention that although the visual appearance of the finished surface is particularly smooth, some small metal chips can be felt by scraping a fingertip on the railhead. This feeling is confirmed by trolley measurements, thanks to its extremely high sensitivity that allows to measure even the tiniest rail irregularities. These irregularities disappear just after one day of traffic on the narrow, bright strip (*running band*) left by trains pass-by (Figure 4); it is therefore recommended to perform longitudinal profile measurements *after some traffic*, in contrast with [2] where it is stated that “it is preferable for measurements to be made immediately after reprofiling”. It is not possible here to give indications on the time needed to remove these small irregularities, possibly depending it from tonnage and local creep conditions.

The centre of the running band was corresponding to the 43 mm lateral position of the trolley probe, and this was selected as the standard position for the all the remaining measurements considered in this paper. No similar running band was found on the high rail.
