IDENTIFICATION AND MONITORING OF OUT-OF-ROUNDNESS OF A METRO VEHICLE BY MEANS OF ACOUSTIC MEASUREMENTS

Prof. A. Bracciali, Dr. F. Piccioli, T. De Cicco

Dipartimento di Meccanica e Tecnologie Industriali
Università di Firenze, via Santa Marta 3, 50139 Firenze

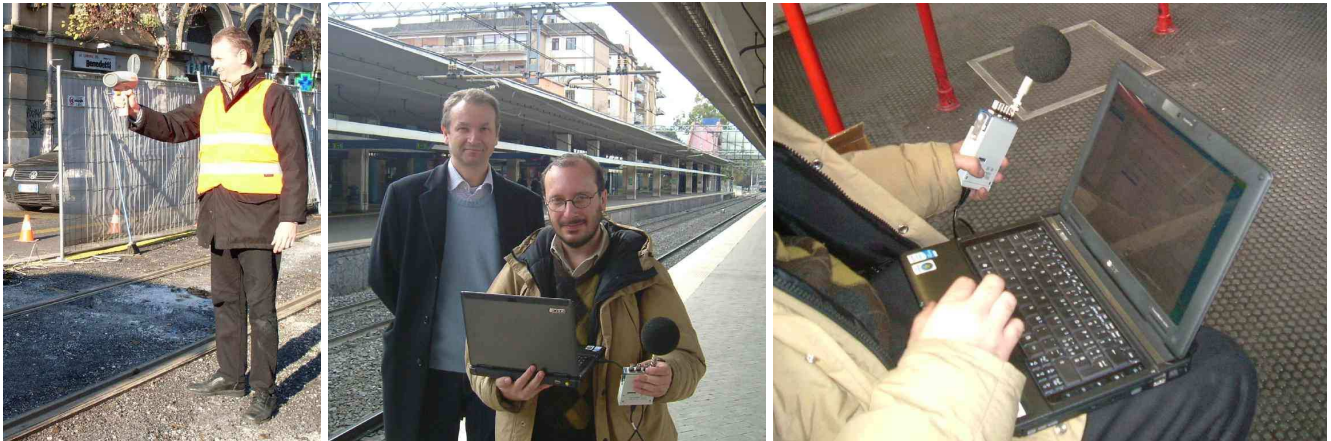
Figure 1: Radar Speed Gun used for speed measurement (left); the authors on the platform waiting for the next metro (centre), during measurements in normal service (right).

Train speed was measured by using a Bushnell Radar Speed Gun placed shallow to the window with the minimum angle φ . The “cosine effect”, i.e. the fact the measured speed v_m and the actual speed v are linked by the equation $v=v_m/\cos(\varphi)$ was evaluated during test runs in the driver’s cab and found to be less than 3% (i.e. speed displayed by the Speed Gun was only slightly less than the real speed). No correction was therefore applied to displayed speeds. Some views of the instrumentations are shown in Figure 1.

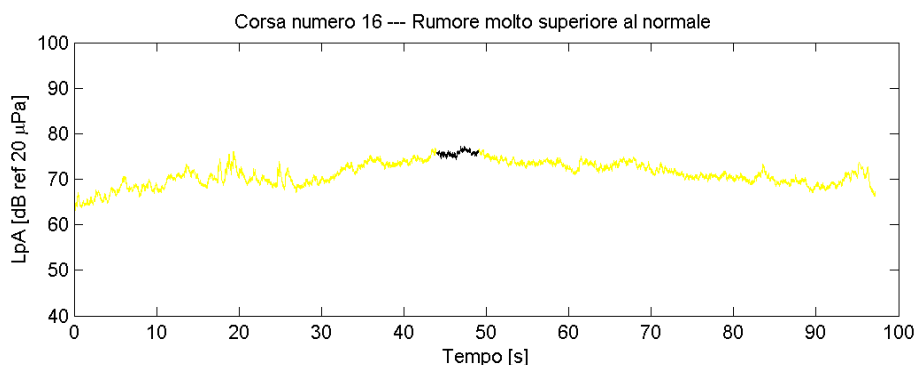
Figure 2: Sound pressure level in the 0-1250 Hz range (A-weighted, FAST time constant) vs. time with indication of a 5 s constant conditions slice. Data are relative to a vehicle reported to be “much noisier than normal”.

- the A-weighted sound pressure level (with FAST time constant) ref. 20 μPa of the decimated signal (Figure 2). The use of A-weighting allows to reach numerical results that are more related to the physiological sensation of noise perceived on board, while the selection of the 1/12 octave resolution, much finer than the usual 1/3 octave, allowed to avoid in the following analysis the inclusion of bands with high resonances that were believed not to be due to the phenomenon under investigations;

- in black in Figure 2, the 5 s time history where it is believed that the noise conditions are sufficiently stationary and suitable to accept the measurement (constant speed, no audible background noise). This selection was done by listening at both the raw and decimated signals;

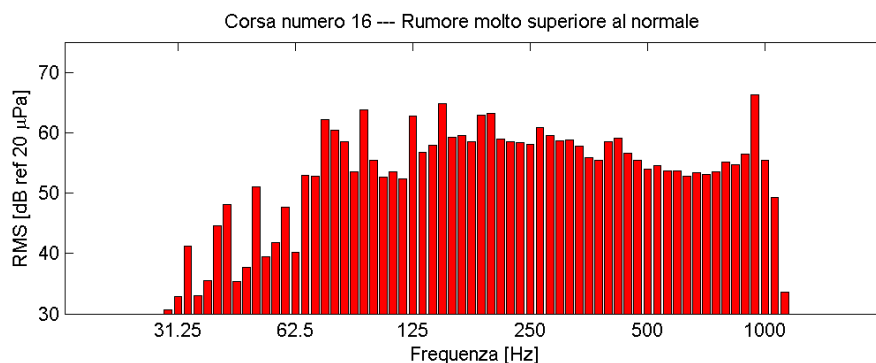
Figure 3: One-twelfth octave band RMS spectrum vs. frequency of the selected slice. Data are relative to a vehicle reported to be “much noisier than normal”..

- the 1/12 octave band RMS spectrum in dB ref. 20 μPa of the selected 5 s section (Figure 3). The use of the energy (Root Mean Square, RMS) indicator for the spectral properties of the signal allows to calculate the power of a given frequency range by simply summing up the energy of the considered bands, as will be shown hereinafter.

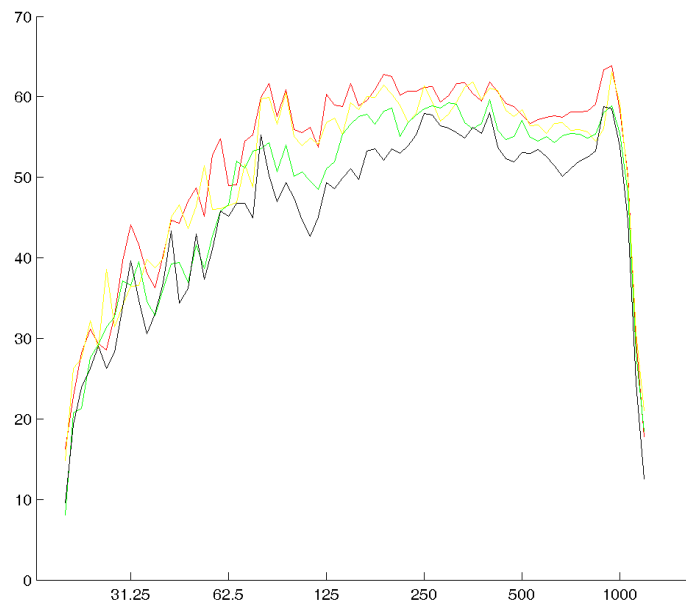
Figure 4: RMS average spectra [dB ref 20 μ Pa] divided for noise category: black=*normal noise*, green=*slightly noisier*, yellow=*noisier*, red=*much noisier*.

Obviously this classification has a meaning only for vehicles with driver's cab (i.e. the front end of Type A traction units). The average noise properties of these four categories can be seen in Figure 4, where their average spectrum is shown per each category.

The average spectra shown in Figure 4 exhibit a certain degree of regularity in the considered frequency range with some exceptions, typically below 80 Hz and above 250 Hz, where the curves seem not to follow the behaviour described by train drivers.

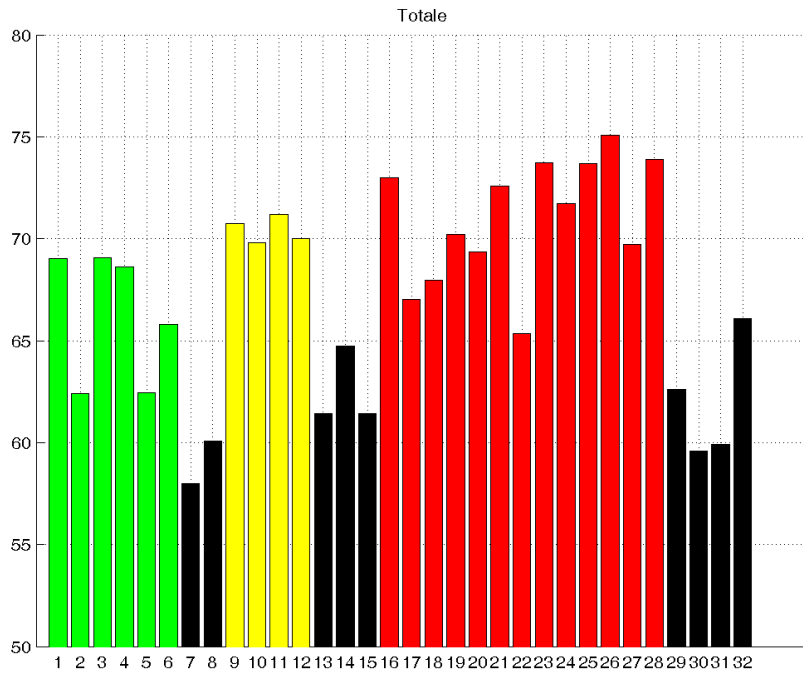
Figure 5: Total RMS values [dB ref 20 µPa] (in the 83÷198 Hz frequency range) for a sample of 32 vehicles divided by noise category: black=*normal noise*, green=*slightly noisier*, yellow=*noisier*, red=*much noisier*.

After a deep analysis it was chosen to select for the identification the total energy falling *only* between and including the 1/12 octave centre bands of 83 Hz and 198 Hz. Figure 5 shows the results of this procedure applied to the first batch of 32 measured vehicles; using this criterion the RMS value shows that the four categories correspond to the following levels:

- *Normal noise*: 59.9 dB (=0)
- *Slightly noisier*: 67.5 dB (=+7.6 dB)
- *Noisier*: 70.1 dB (=+10.2 dB)
- *Much noisier*: 71.6 dB (=+11.7 dB)

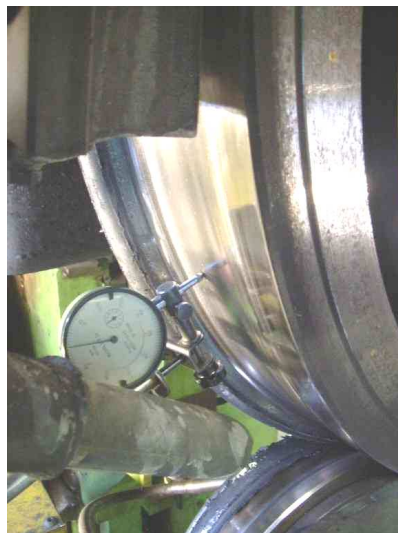
Figure 6: OOR measurement with 0.01 mm dial gauge.

After noise measurements, wheels belonging to vehicles that were recognized to be *much noisier* than the normal were measured with the vehicle resting on the underfloor lathe available in the maintenance workshop. The method used is the classical one comprising a 0.01 mm dial gauge mounted on a magnetic base. The measurement of the trend of OOR (wheel radius) is recorded taken notes on paper by the operator (Figure 6).

From these measurements it came out that the defect is of stochastic type. From the paper by Nielsen, “this type of OOR may be caused by unbalances in the wheelset or by inhomogeneous material properties of the wheel... it can be concluded that the stochastic shape contains several different harmonics”. This explains why no defined frequencies were found in the spectra recorded on board.

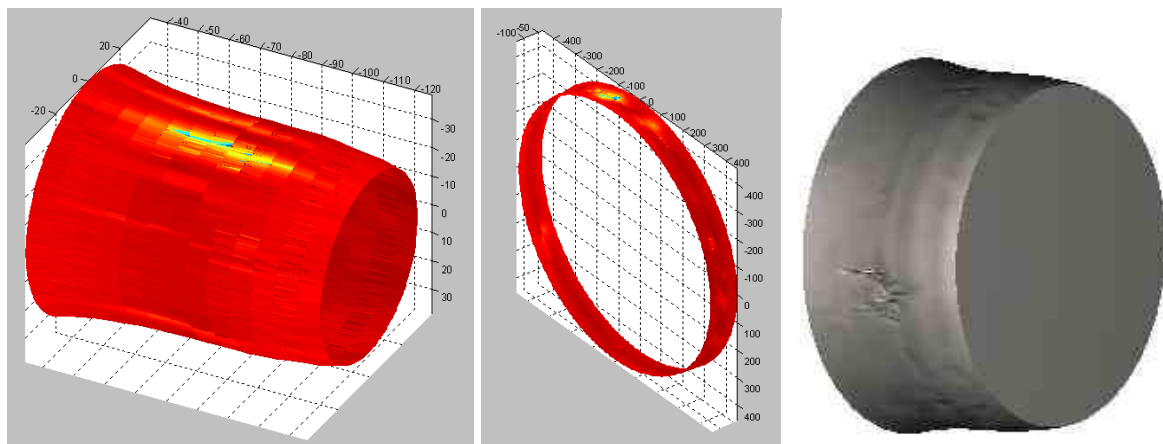
Figure 10: Three different graphical reconstruction of the measurements made with the “comb” on a wheel with a shelling defect on the tread.

Although the resolution of the equipment is lower than the classical dial gauge (0.05 mm instead of 0.01 mm), the potential of the instrument are evident. The typical output of this measuring tool is shown in Figure 8, Figure 9 and Figure 10.
