Restoration of Switch Manganese Steels Crossings by Electric Arc Welding in a Robotized Plant

A. Bracciali¹ and M. Salciccia²

¹**Dipartimento di Ingegneria Industriale, Università di Firenze, Italy**

²**SAGA s.r.l., Scurcola Marsicana, L'Aquila, Italy**

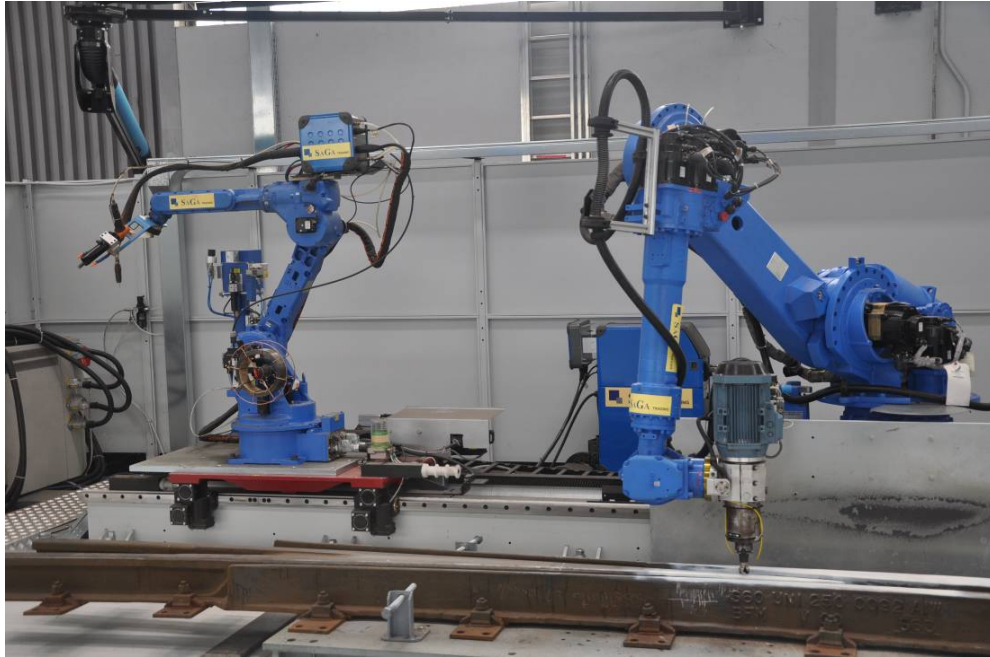
Figure 3: Welding robot R2 (Yaskawa MOTOMAN HP20D) equipped with the wire feed unit and the 19-needles scaler Beta 1944 (left). Milling robot R1 (Yaskawa MOTOMAN ES165D) equipped with measuring probe and milling spindle (right).

Robot R2, smaller, is dedicated to welding and removal of slag between passes. It bears a wire feed unit Migatron RWF Multifeder and a cleaning tool. The MIG welding machine Migatron SIGMA² 500 C is located aside the robot [9]. Robot R1, bigger, is equipped with a M&H 8704 machine tool dimensional measurement probe [10] that is used to locate the crossing to be machined w.r.t. to the robot reference system. A $d=40$ mm SECO mill with four Square 6TM XNEX 080608TR-M13 MP3000 [11] inserts is the used to removal the damaged portions of the crossing before welding and for finishing after welding (Figure 3).

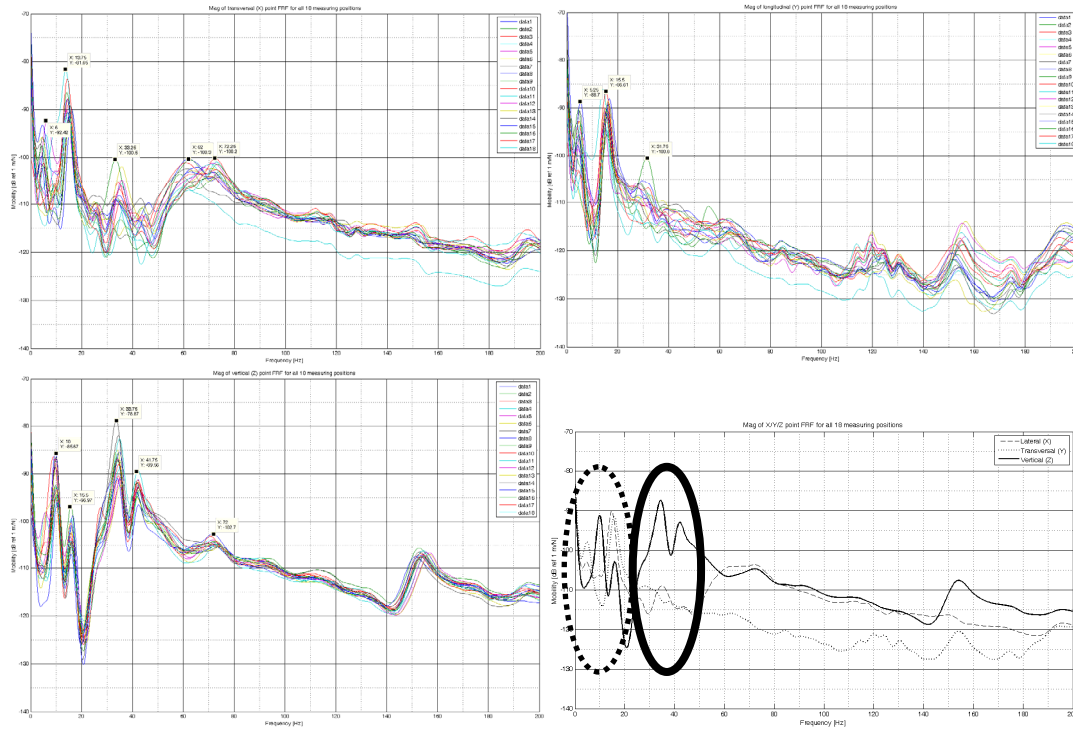
Figure 7: Vertical receptance in X (top left), Y (top right) and Z (bottom left) directions. Superposition of average curves (bottom right) with indication of the lateral/transverse resonance (in the dashed ellipse) and of the vertical resonances (in the thick line ellipse).

Receptances (mobilities) were therefore derived from inertances, and are shown in Figure 7. It can first be observed that mobilities are scarcely influenced by the working position, allowing a comparison also of average curves.

The most important resonance in the transversal X direction and in the longitudinal Y direction are respectively at 13.75 Hz and at 15.5 Hz. Both these frequencies are rather low. Quite different is the situation on the vertical Z axis, where beyond two peaks at low frequency (10 Hz and 15.5 Hz), the response is dominated by the peaks at 33.75 Hz and, to a minor extent, 41.75 Hz. Above around 25 Hz, the response in the vertical direction is more than 100 times that in the other directions and this, as indicated the following, is the region where spindle should rotate to optimize cutting.

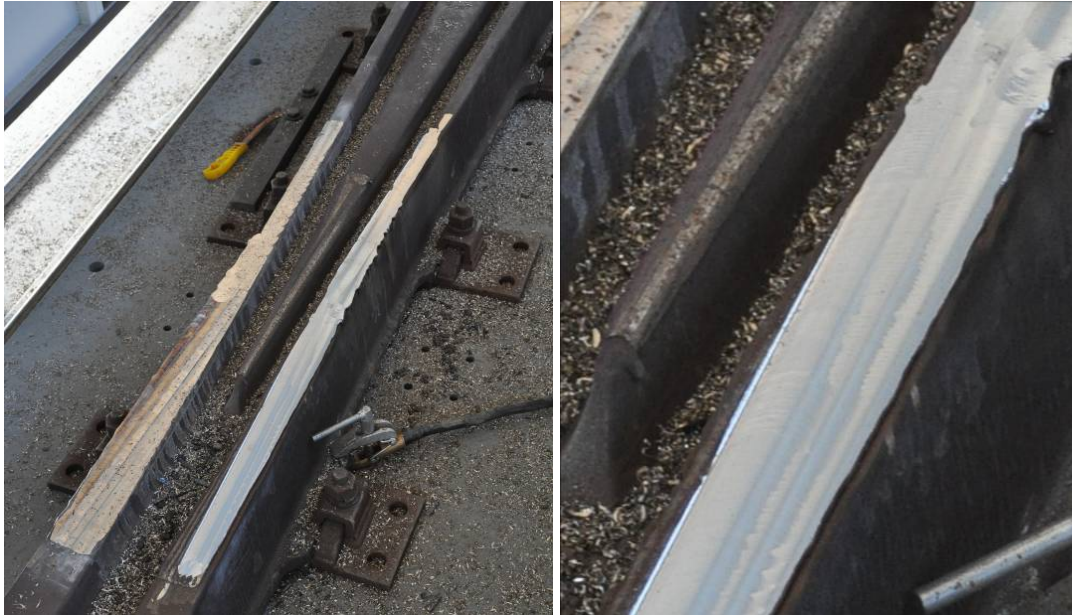
Figure 10: Example of the quality of crossing surface after final milling.

These selections led to exceptionally stable machining conditions (Figure 10) which are in line with those that can be obtained with much larger, heavier, more expensive and less flexible milling machines.
