Railway Wheelsets: History, Research and Developments

A. Bracciali
Dipartimento di Ingegneria Industriale
Università di Firenze
Italy

The paper describes the history and the architecture of trailing railway wheelsets. Improvements in the design are described as well, showing remaining unsolved criticalities. Scientific literature on the subject is analyzed, highlighting the wide importance that axles still hold. Some relevant accidents resulting from wheelset failures are described. A novel design of a wheelset studied to improve safety, reduce maintenance, and reduce LCC, is introduced.

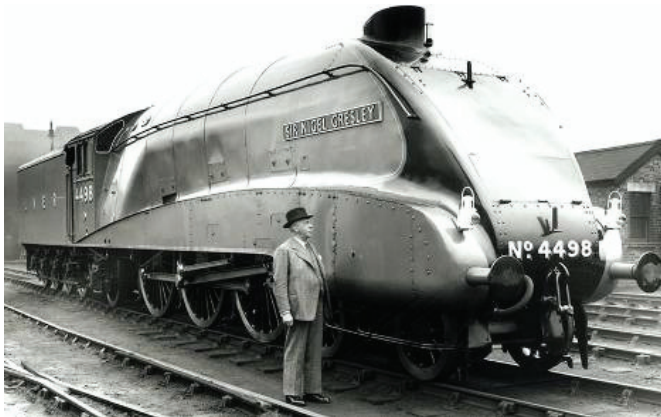
Figure 2: LNER Class A4 4498 "Sir Nigel Gresley", pictured with the celebrated steam locomotive designer. She is a sister of "4468 Mallard", the fastest and one of the most famous steam locomotives of all times [2]

Inboard bearings were commonly used for steam locomotives with external cylinders for more than 150 years, as connecting and coupling rods were located external to the frame. Even the much more recent Sir Nigel Gresley's locomotive LNER Class A4 4468 "Mallard" (1938), holder of the speed record for steam locomotives at 202.58 km/h [2], used this arrangement (Figure 2).

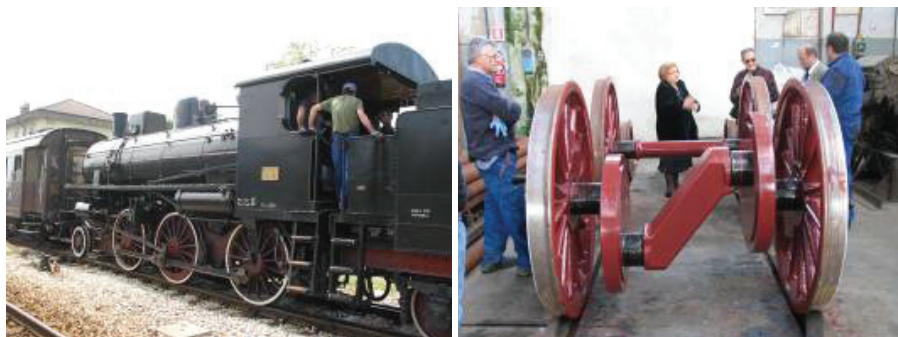
Figure 3: Class 625 locomotive of the FS (Italian State Railways) pictured during a revival train (Bornato, Italy, 15.05.2005). Driving and coupled wheelsets pictured at the Historical Rolling Stock depot in Pistoia, Italy. Journal seats and crankpins for driving rods are clearly visible. Both photos by the Author

Also, many steam locomotives with internal cylinders, equipped with a crankshaft for the driving axle, had external connecting rods and, therefore, inboard bearings (Figure 3).

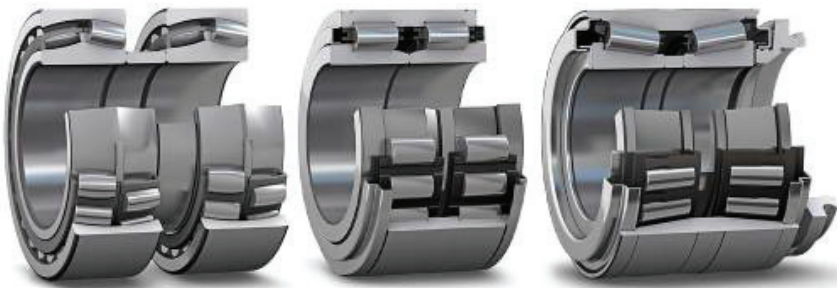
Figure 6: Different types of composite bearings (left: spherical) and compact units (mid: cylindrical rolling, right: tapered rolling) (adapted from [3])

At the beginning of 20th Century, rolling bearings were also developed for railway applications (Figure 6). Because of the lower resistance to motions and lower maintenance, they soon supplanted sliding bearings. The use of rolling bearing units (“cartridges”) consisting of either two tapered rolling bearings mounted in a back-to-back (“O”), or two cylindrical rolling bearings arranged with a common outer race, is widespread nowadays.

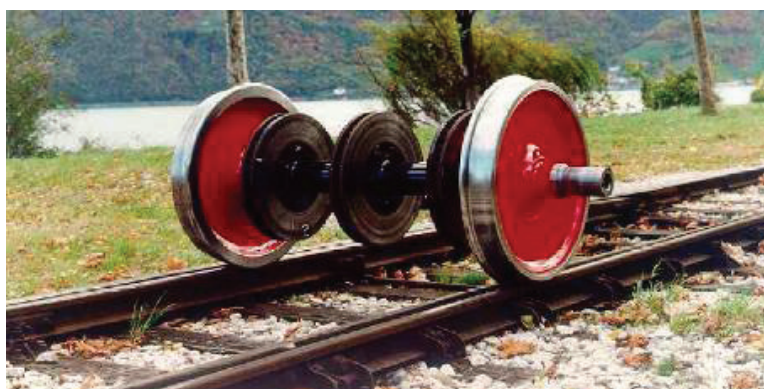
Figure 11: Application of damping treatment on the wheel web of a high-speed train wheelset in order to reduce wheel vibrations and therefore emitted noise (*Syope* treatment, Lucchini RS, [4])

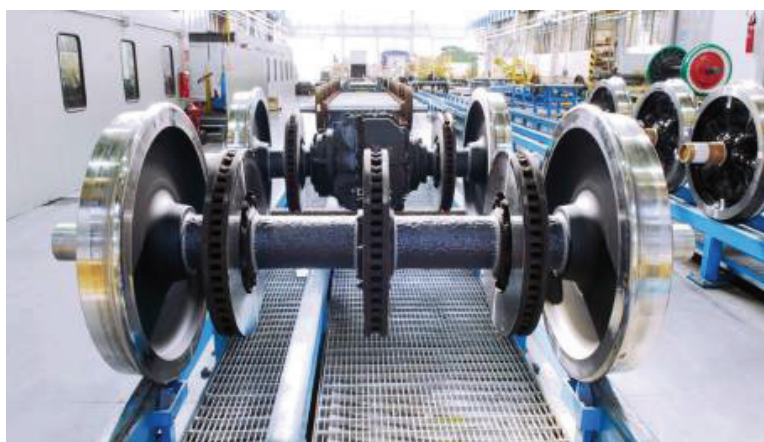
Figure 12: Application of anti-ballast shock protection layer on the axle (*Lursak* treatment, Lucchini RS [4], [11])

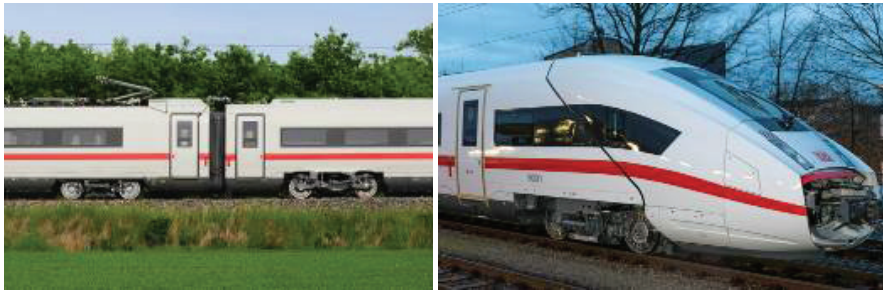
Figure 13: The new ICx trainset for German Railways DB. Left: a trailing bogie (*FlexxECO* made by Bombardier Transportation) and a motor bogie (made by Siemens AG) on two adjacent cars. Right: the driving trailer car equipped with *FlexxECO* bogie

Vehicles which have wheelsets with inboard bearings are particularly common in the UK because of their reduced track access charges as a result of their higher track friendliness. A short market analysis which reports on the most recent rolling stock using inboard bearings, is shown in [13]. Outside the UK, probably the most interesting application is the Deutsche Bahn ICx trainset. Some pictures of this train and some inboard bearings bogies are shown in Figure 13 and in Figure 14.

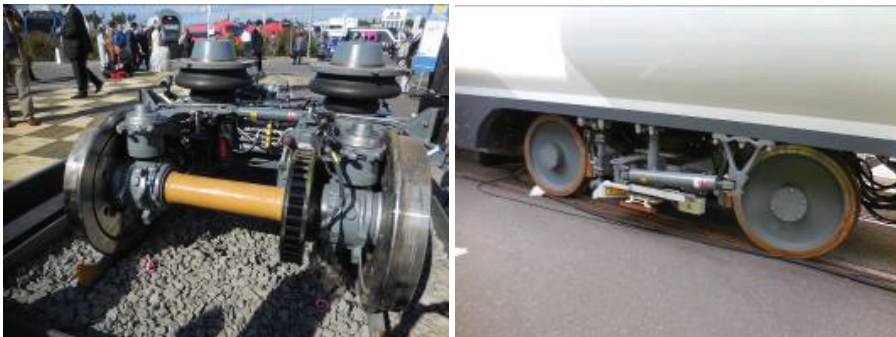
Figure 14: Detail of the trailing bogie Bombardier *FlexxECO* for ICx (left) and Siemens Desiro City Thameslink (right) (Innotrans 2014, Berlin)

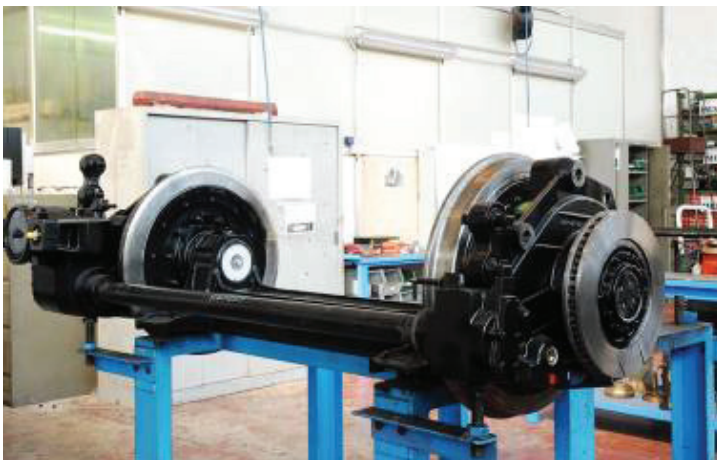
Figure 18: Driving axle of the AnsaldoBreda Sirio vehicle. The shaft connecting the two wheels is in the foreground [4]

Solutions in which IRW are connected through transmission elements are common in low-floor vehicle motor bogies (see an example in Figure 18). This arrangement is limited to low-speed low-axleload vehicles running in tight curves (the transmission is often equipped with differential gearboxes and/or clutches) and is used only on motor bogies that, as already stated, are not further addressed in this article.

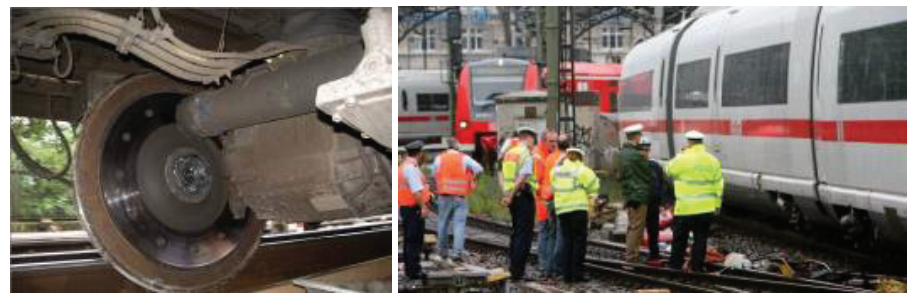
Figure 22: Broken axle of the IC518 ICE3 train in the Köln main station, 9.7.2008. Left: the broken driving axle seen from the internal side. Right: investigators looking at the derailed train [24]

The first accident happened on 9 July 2008 at the central station in Köln, Germany, and affected a driving axle of an ICE3 trainset (Figure 22).

Luckily the train derailed as a result of the broken axle when it was running on the switches at very low speed and, therefore, there were no major consequences. A very interesting failure analysis is reported in [24], which states: “...immediate measures: substantial reduction of UT-inspection interval (EBA 10.7.2008: UT of all axles made of 34CrNiMo6 60.000 km instead of 300.000 km), currently: 30.000 km” and: “all ICE3 driving axles will be changed”.

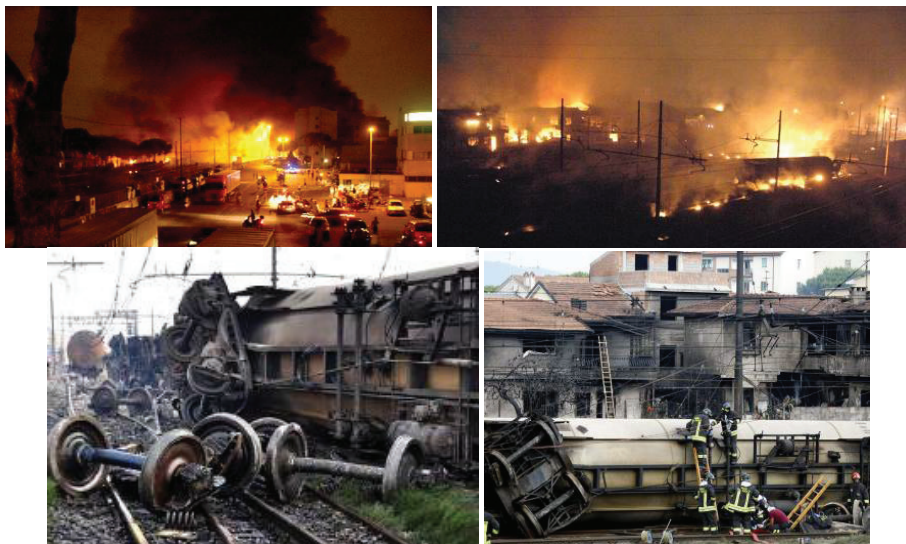
Figure 24: Some snapshots of the apocalypse which struck the peaceful town of Viareggio during the warm summer night of 29 June 2009

A less fortunate case is the axle failure which was responsible for one of the most tragic railway disasters which happened in Europe in the last decade. The freight train 50325 Trecate-Gricignano, composed of a locomotive and 14 tanks carrying LPG, derailed in the Viareggio station, Italy, on 29.6.2009 (Figure 23 and Figure 24).

The derailment was as a result of the sudden failure of the leading axle of the first wagon. After the derailment, the tank wagon overturned and started leaking LPG which, after a few minutes, caught fire, burning a large area around the railway station and killed 32 people. Many more were injured with severe burns. The criminal trial is still in process to ascertain who was responsible for this accident.

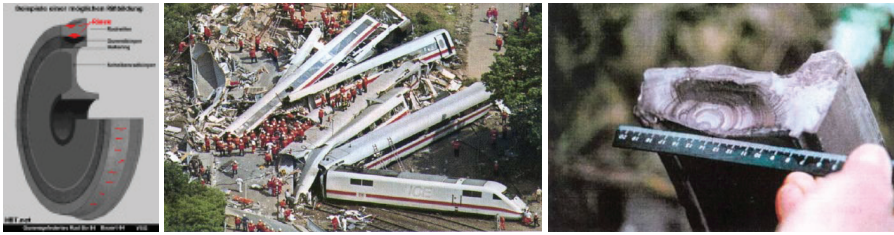
Figure 27: Sketch of the BA 064 wheel (left, from <http://www.ndt.net/news/2000/eschedec.htm>). An image on the aftermath of the disaster (centre, from <http://uncyclopedia.wikia.com/wiki/File:Eschede-1.jpg>). Fractured tyre section (right, from <http://www.soue.org.uk/souenews/issue6/jenkinlect.html>)

The official investigation was, obviously, rather long. Paper [34] indicates that the tyre split as a result of a fatigue failure that initiated in its internal part. Although all the wheels that were subsequently examined did not show any crack or progressive defect, supporting "the presumption of a rare or singular event which could have initiated the crack", DB immediately retired all the wheels, marking the end of the only conventional railway application of an elastic wheel.

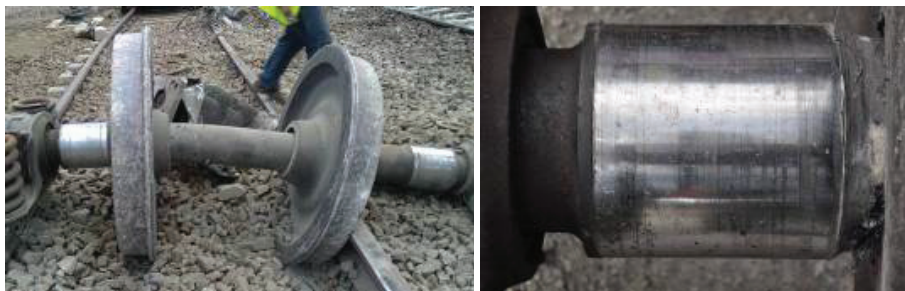
Figure 28: Displaced wheels from the wheelset on the first wheelset of the wagon (left). Aspect of the surface after wheel displacement revealed no defects or damages typical of wheels pressing off (right) [39]

Some accidents happened in the last years as a result of a wrong fitting process. In a case, which the author has already discussed [39], the accident that happened on the Brenner line on 6.6.2012 (Figure 28), several wheelsets displaced laterally resulting in the derailment of several wagons of a train carrying scrap steel. In another case (Maccarese, Italy, 10.02.2010), the wheel of a passenger car moved towards the axlebox and the wheelset derailed on a switch (Figure 29). In Verona, quite recently (13.02.2015), a freight wagon derailed in a marshalling yard as both the wheels of a wheelset displaced laterally leading also, in this case, to a too small wheelset gauge (Figure 30).

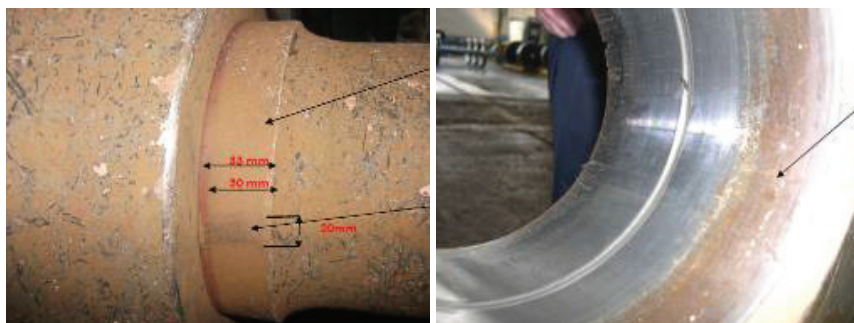
Figure 29: Displaced wheels towards the axlebox of a passenger car (left). Aspect of the wheel bore after dismounting during the investigations (right) [40]

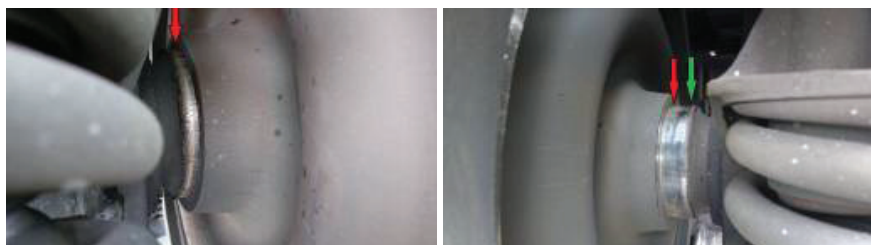
Figure 30: Both wheels displaced of a freight wagon in Verona (13.02.2015)

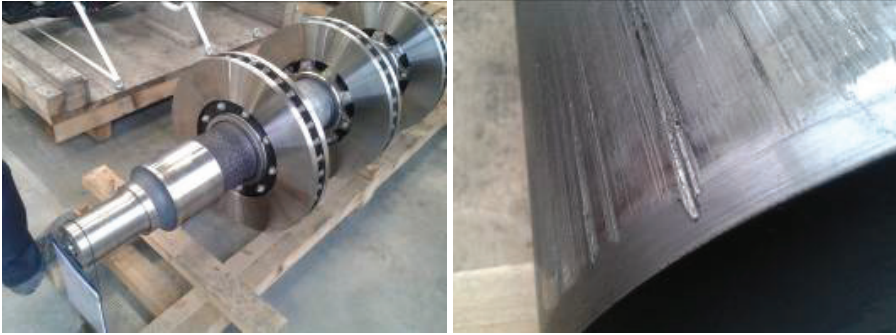
Figure 31: Consequences of a misfit of a wheel on a wheelseat. The deepest grooves are originated by the wheel removal process (photo by the author, 2013)

A different type of damage is seldom observed during press-fit mounting as a result of conditions that are sometimes hard to discover. Figure 31 shows the consequences of a wrong press-fitting procedure applied on a passenger car axle. In some cases, this damage can be fixed, but in most cases both the axle and the wheel(s) must be scrapped, with evidently high costs.

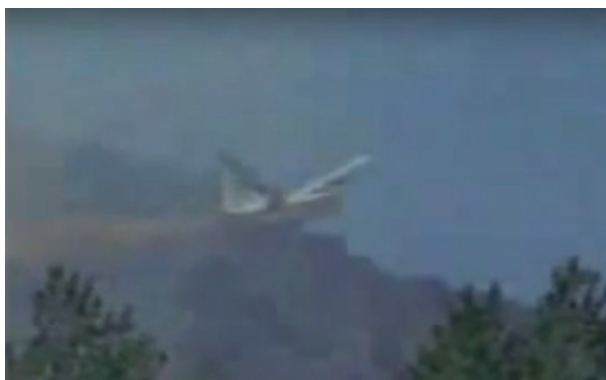
Figure 33: Frame taken from the video of a Lockheed C-130A that crashed as a result of a fatigue failure of wings [44].

On 17 June 2002 a Lockheed C-130A, N130HP, broke apart in flight while executing a fire retardant delivery near Walker, California. As indicated in the official investigation report [43], the cause was “the in-flight failure of the right wing as a result of fatigue cracking in the centre wing lower skin and underlying structural members. A factor contributing to the accident was “inadequate maintenance procedures to detect fatigue cracking.”. The whole event took about 4 seconds and was captured on video by a passer-by (Figure 33).
