Paper 312

# Elimination of Failures in Railway Gearboxes by Regenerative Coasting

### A. Bracciali and F. Piccioli Dipartimento di Ingegneria Industriale Università di Firenze, Italy

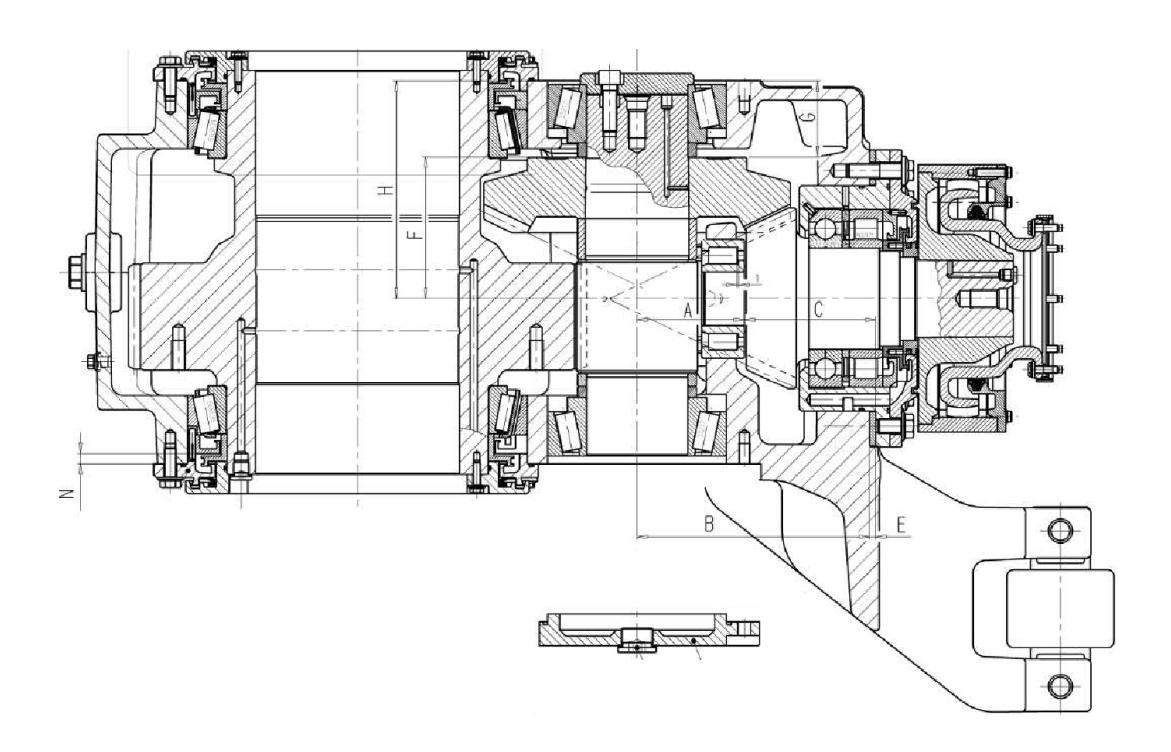
Figure 3: Gearbox section. One of the covers of the intermediate shaft is shown displaced

As already mentioned, gearbox failures happened for the overwhelming majority of the cases on Line 3. The consist in the break of the cage of the taper roller bearing located on the intermediate shaft, opposite to the bevel gear (see Figure 3). As a precursor of the complete failure, abnormal distortion and wear of the cage can be observed by properly measuring the axial play of the intermediate shaft. Although these checks allowed to completely avoid failures during operations and related consequences, any time an abnormal play is found both bearings of the intermediate shaft are changed with unacceptable material and workforce costs. Although fleet availability was unaffected, the manufacturer was claimed to solve the problem and involved the authors to investigate the root causes of the failures.

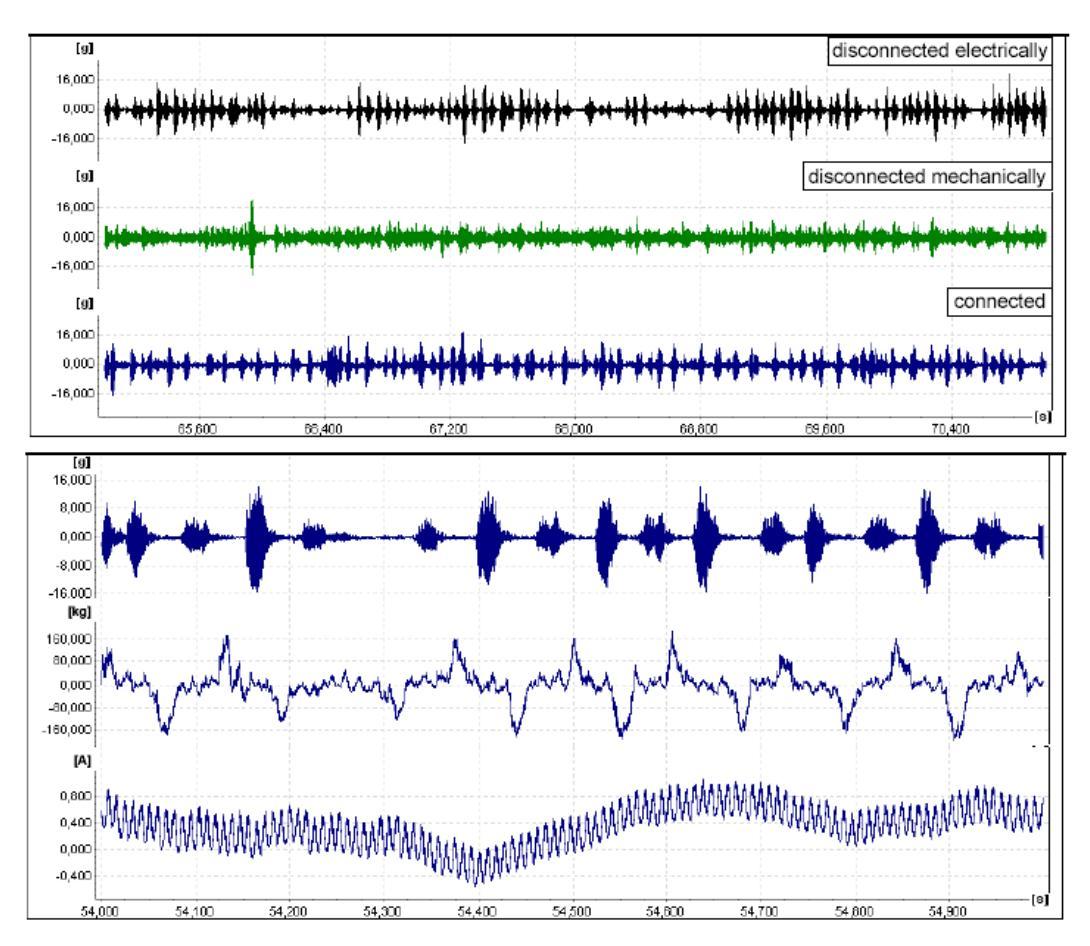
As known, the best sensor to monitor the conditions of a running equipment is the accelerometer. Several measurements were available when this work was started, all of the them reporting "erratic spikes of high level" during both test runs and normal operation conditions. An example of what was observed is shown in Figure 10, where gearbox vibrations are compared to forces measured by using strain gauges bonded to the reaction rod. It looks clear that the reaction rod forces changes regularly its sign, showing a vertical oscillatory movement of the whole gearbox. Packets of vibrations is coasting contain both gear meshing frequencies.

Figure 10: Vibrations in coasting at around 80 km/h. Top: accelerations recorded when motor and joint are electrically disconnected (inverter off), mechanically disconnected (joint opened) and connected (inverter on). Bottom: vibrations of the gearbox, stresses in the reaction rod and motor current

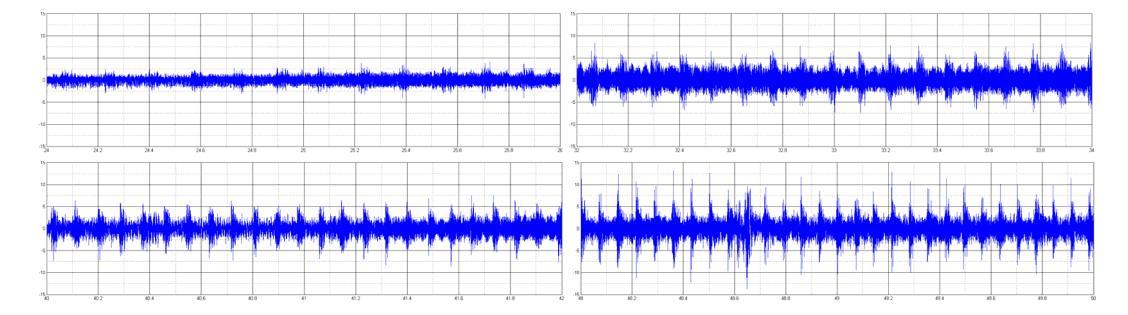
As long as acceleration spikes number and amplitude were found to both increase with speed (Figure 14), a deeper analysis of the data led to the conclusion that there was a relationship between the vertical resonances of the gearbox and the acceleration levels recorded during test runs. As shown in Figure 15 and in Figure 16, the correlation between maximum acceleration values and the highest peak in the gearbox vertical response was clear.

Figure 14: Accelerations recorded at the reaction rod attachment at v=30 km/h (f=6 Hz), v=45 km/h (f=9 Hz), v=58 km/h (f=11.5 Hz) and v=72 km/h (f=14 Hz)

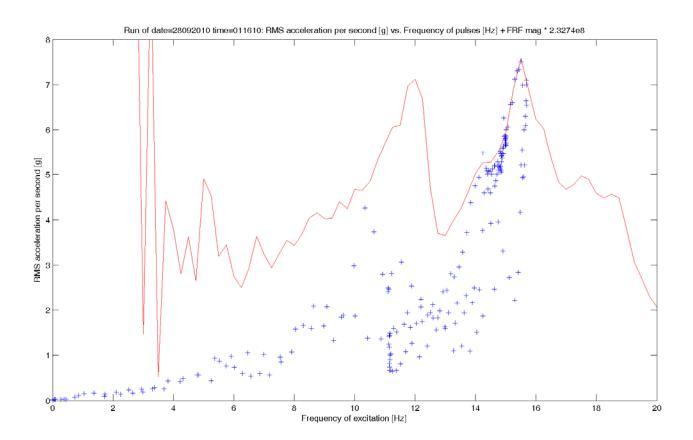
Figure 16: Signals recorded during a full test run. Frequency response function measured with impact hammer (red, joint disconnected) compared to RMS energy as a function of frequency (=speed)

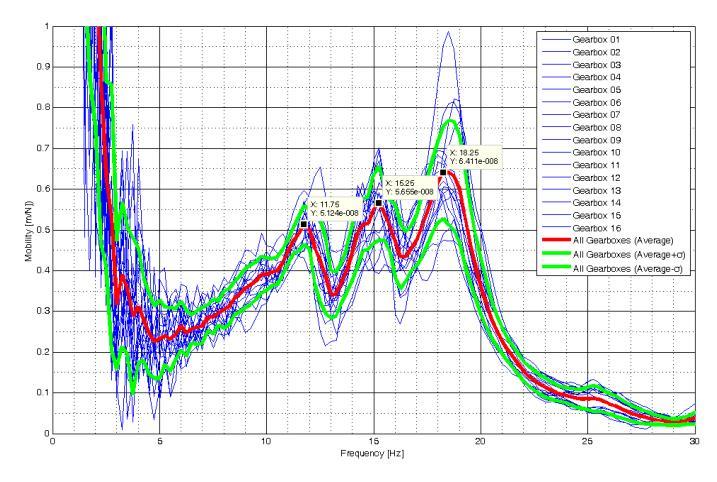
As the importance of gearbox natural frequencies was evident, all the gearboxes of a different train were tested with the impact hammer, leading to the results shown in Figure 17. All the gearbox appeared very similar, leading to the conclusion that the failures were possibly due to the coincidence of the forcing function and the natural frequency of the gearbox (resonance condition). Eight gearboxes of this train were therefore equipped with accelerometers and measured but the data were unusable as *all channels saturated the*  $\pm 50$  *g range*, showing damages in all the gearboxes.

Figure 17: Frequency response function of all the gearboxes of a train. Joint is connected

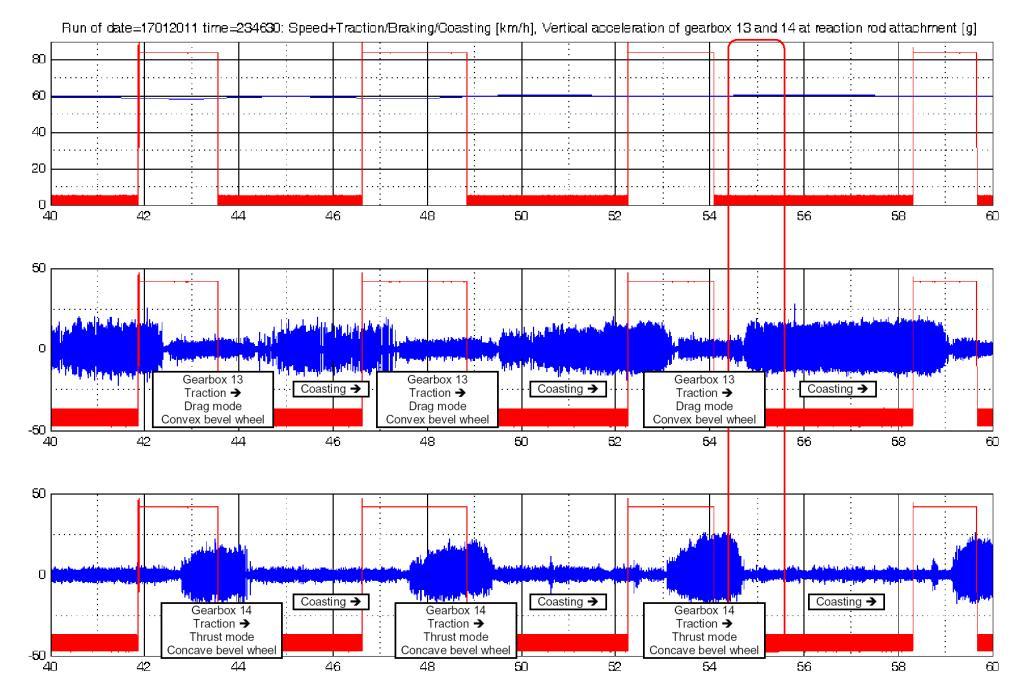
Tests were repeated on a different train and, quite surprisingly, the accelerations did not show any clear relationship between amplitude and frequency with speed and the spikes were again quite erratic (Figure 18). It was therefore concluded that the results found before were only due to a gearbox *that was already damaged* at the time of the measurements. The hypothesis of a root cause due to resonance was therefore discarded: the dynamic system was *tuning itself on the vertical natural frequencies that "drove" the system to oscillate at that frequency and to produce spikes at that frequency*. When the damage was removed, by choosing a different train, that coincidence disappeared. Reversing from traction to braking the torque in the gearboxes, different teeth flanks meshing conditions (see Figure 19) led to clear changes in the average acceleration levels (Figure 20). Different meshing conditions also affected vibrations during coasting (Figure 21).

Figure 20: Acceleration levels during thrust and drag mode for two gearboxes (A and B) belonging to the same bogie

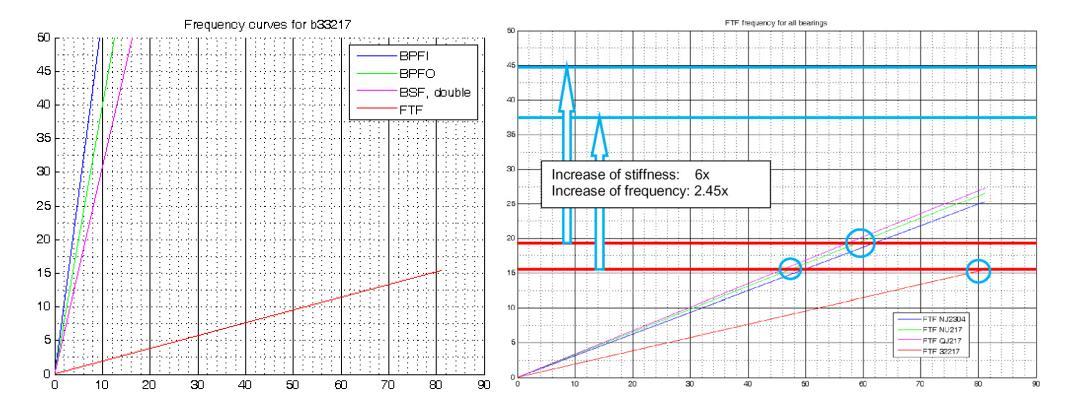
The frequencies due to possible defects on the rollers and on the races (BPFO= ball pass frequency on outer race, BPFI= ball pass frequency on inner race, BSF= ball spin frequency, FTF= fundamental train frequency) were all analysed for the taper bearings of the intermediate shaft and a proposal to increase the stiffness of the rubber elements of the reaction rod was made to shift outside the range of normal

speed the excitation frequency of the *FTF*, which is related to defects in the cage (Figure 22).

Figure 22: Passing frequencies [Hz] in taper roller bearings of the intermediate shaft vs. speed [km/h] (left). Effect of increase of the vertical stiffness on vertical natural frequency of the gearbox compared to FTF frequencies of all bearings inside the gearbox (right)

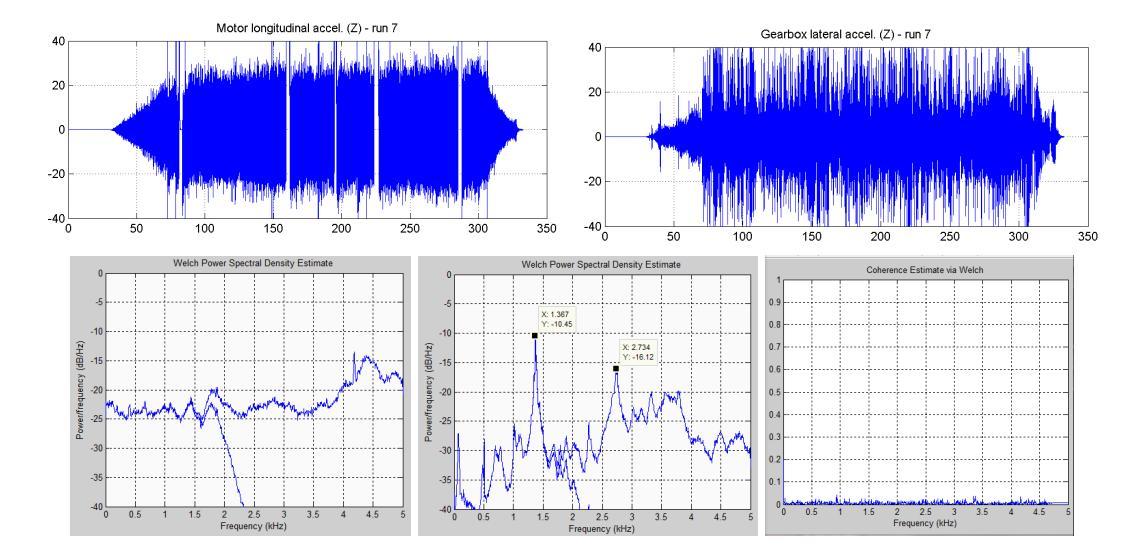
The joint connecting the motor and the gearbox is shown in Figure 25. It is a torsionally rigid joint with spherical gears acting on internally splined shafts. This joint is very often used in this kind of applications, as it effectively decouples the motor (which is connected to the bogie frame) and the gearbox (which embraces the axles and is suspended by the reaction rod). Motor and gearbox vibrations have in fact similar levels but different frequency content and the coherence between the

two signals is always very low. Motor vibrations are random in nature while gearbox vibrations are dominated by meshing frequencies of the two gears (Figure 26).

Figure 26: Top: motor (left) and gearbox (right) accelerations (inverter off, 80 km/h). Bottom: Motor (left) and gearbox (centre) acceleration PSD estimates and coherence (right)

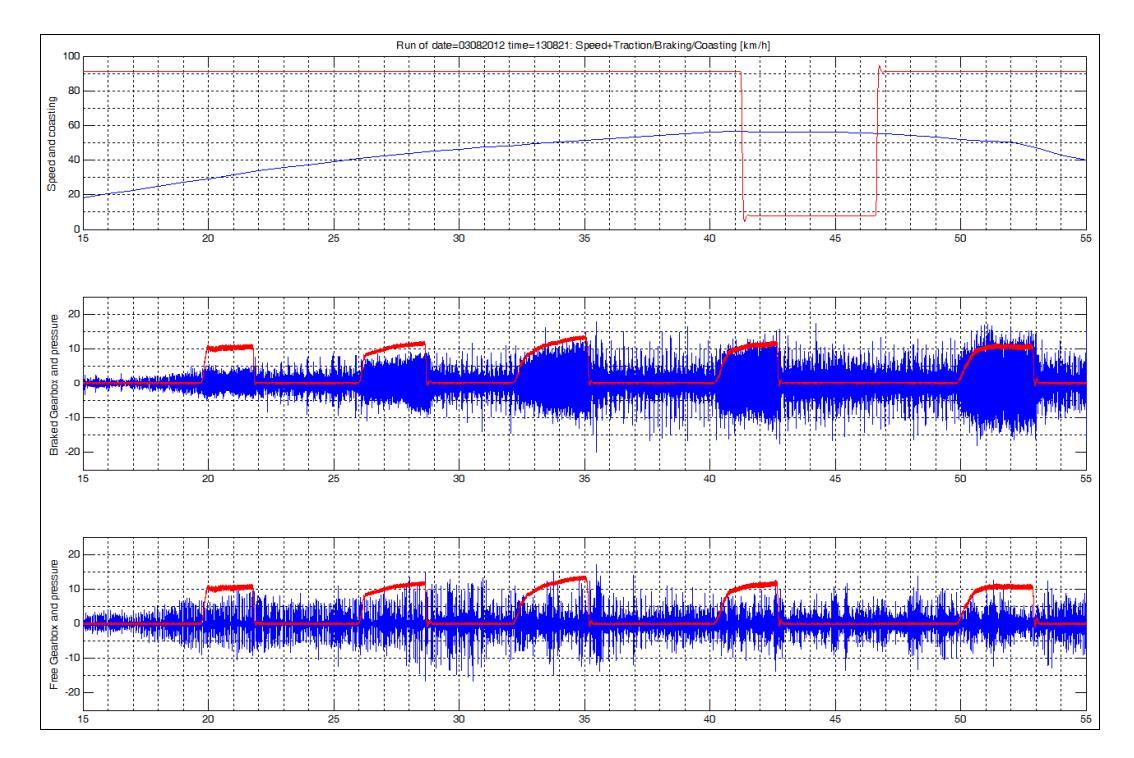
Tests were performed in August 2012 in a specific track in a depot, up to a maximum speed of 60 km/h. The track was preliminary qualified in terms of defectiveness by using the criterion described above. An example of the results is shown in Figure 30 and in Figure 31. It is evident that the braking system introduces large modifications in the vibrations measured on the gearbox, changing the shape of the signals and their frequency content. The companion paper [1] discusses the application of an original signal processing procedure to the data from this measurement campaign and also to the previous ones to check its soundness and its general applicability.

Figure 30: Top: speed and coasting signals. Mid: acceleration of the "braked" gearbox (mid) with pressure in the braking system (in red). Bottom: accelerations of the reference gearbox (bottom, pressure signal in red for reference only)

As a result, braking and torsional preload increase energy level of vibrations (RMS value) but decreases the "spikiness" that can be evaluated by using the kurtosis function. These tests were considered therefore very promising showing that such a system positively affects the bouncing behaviour of the gearbox. Although the test system is definitely not applicable as a retrofit to the fleet, its validity as a demonstrator remains unchanged.

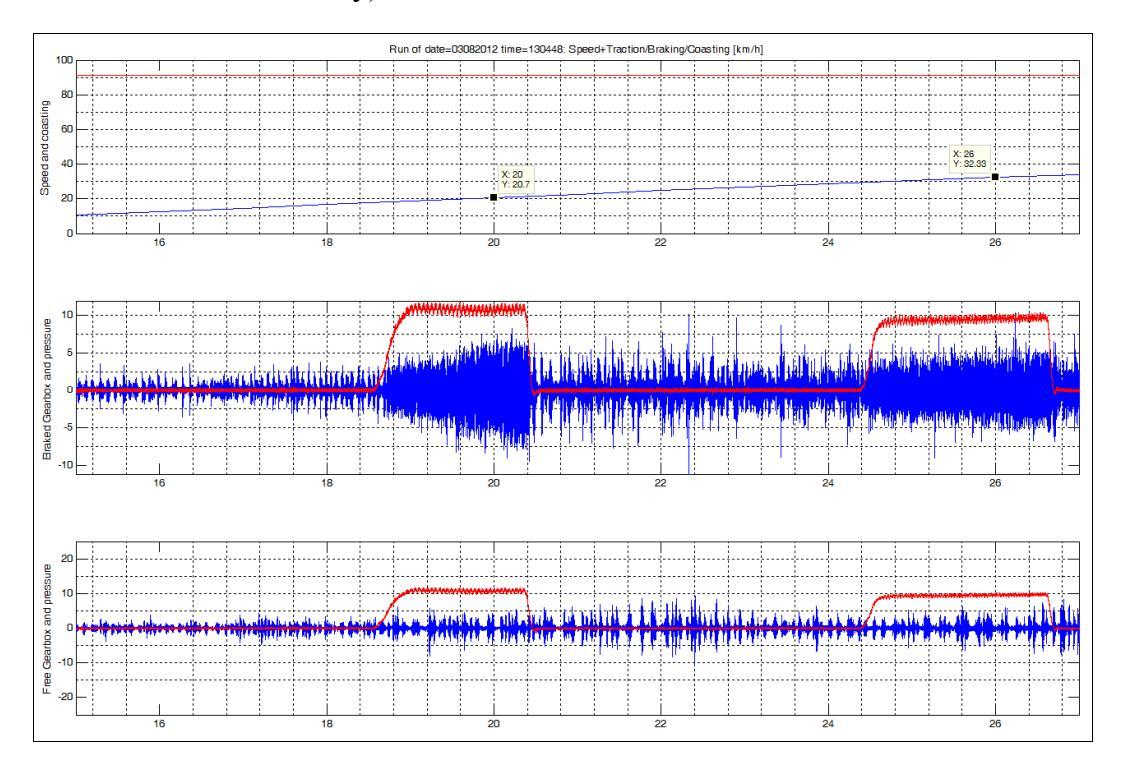
Figure 31: Close-up of a low-speed test run highlighting the influence of braking on acceleration signal measured on braked gearbox (mid trace)

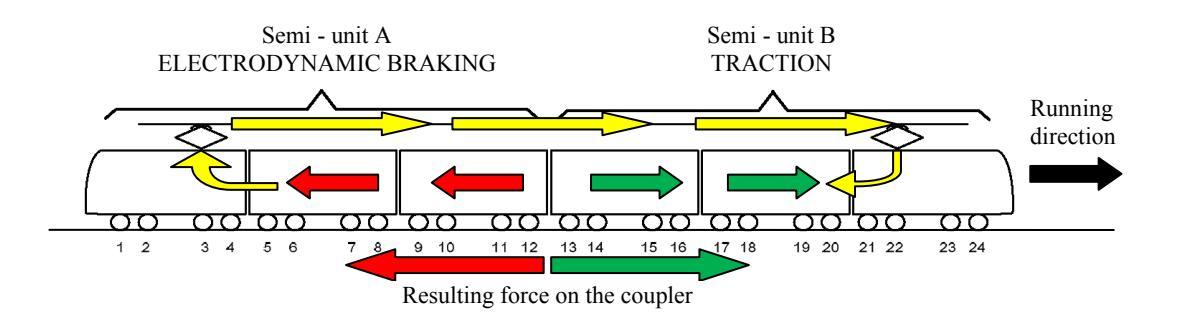
Figure 32: Explanation of the "regenerative coasting" process with braking forces (red), traction forces (green) and current flowing on the overhead line (yellow). Resulting force on the central coupler is also indicated

Once it was realised that a torque and/or damping can totally avoid the presence of spikes, the authors proposed to the train manufacturer a possible solution based on power recirculation that is explained in Figure 32.

- the rear semi-unit (A, in this case) starts braking electrodynamically with a predefined fraction of the maximum braking effort, generating a certain current with a voltage which is sufficient to be fed back to the overhead line;
- the current flows from the rear pantograph to the front one, feeding the front part of the train;
- the front semi-unit (B, in this case) collects the current from the pantograph giving an identical level of traction;
- by simply deriving from the overhead line the (minimal) energy lost in the conversions, this process, named "regenerative coasting", can give a predetermined preload to all the gearboxes in the train;
- the resulting force of the coupler is a fraction of its design value and has therefore no influence of its fatigue life.

Regenerative coasting has the great advantage that can be implemented by making quite simple modifications to the traction software that do not affect safety (traction or braking portions of the software remain unchanged). Retrofit to a fleet simply requires the upload of a revised version of the software via an Ethernet cable.

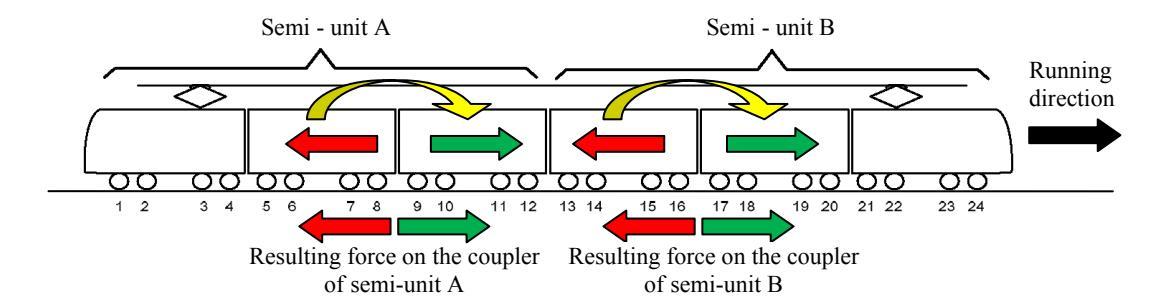
Figure 35: Different regenerative coasting implementation which eliminates the force on the central coupler resulting in lower forces on internal coupler of each semi unit. No power recirculation through the overhead line is needed and the semi units are completely independent

The final application policy on the trains that were affected by the problem is ongoing and should be finished by the first months of 2014. The key factors which will drive the definition of the regenerative coasting percentage selected will be the line quality, the initial conditions of the gearboxes and the extent to which software can be modified. A different regenerative coasting strategy could lead for example to much better results, as shown in Figure 35.
