## **Naturally Hard Steel Rails: Development and Feedback from Service**

**A. Bracciali and F. Piccioli**  
**Dipartimento di Ingegneria Industriale**  
**Università di Firenze, Italy**

### **Abstract**

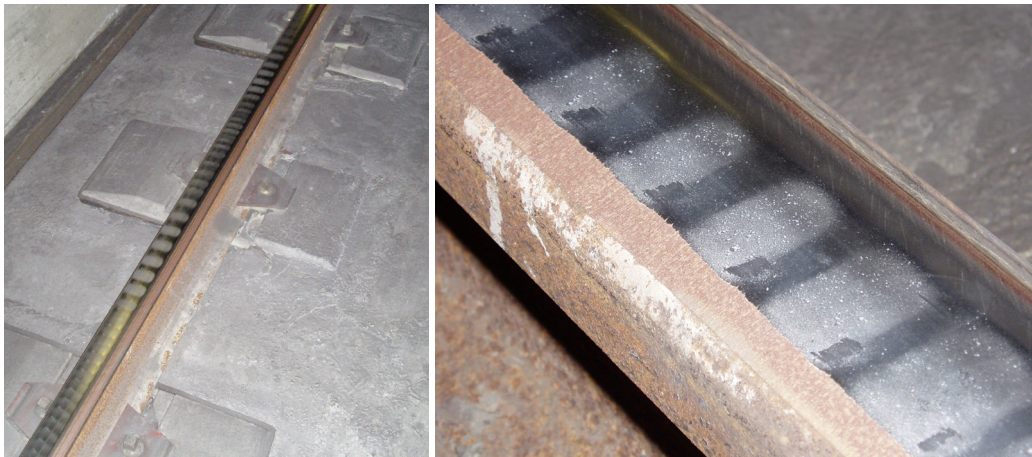
Figure 1: Rail corrugation appearance in a curve with floating slab track on Naples metro.

As long as the metro was built in different periods of time, a mixture of track formations exist (ballast, concrete slab, floating slab) and rails of different steel grades are used, namely R220 steel [6] is used in the Northern part of the line (opened until 1995) while R260 steel is used in Southern part of the line (partly still under construction), all with 60E1 section. It was therefore decided to test *VAR110* rails in three different locations, where historical data (in terms of rail corrugation measurements before and after grinding) were available since long time. This was done with the goal of testing the rails in different service situations (traction, braking, track formation, curve radius) where corrugation recursively appears (see Figure 1 for some examples).

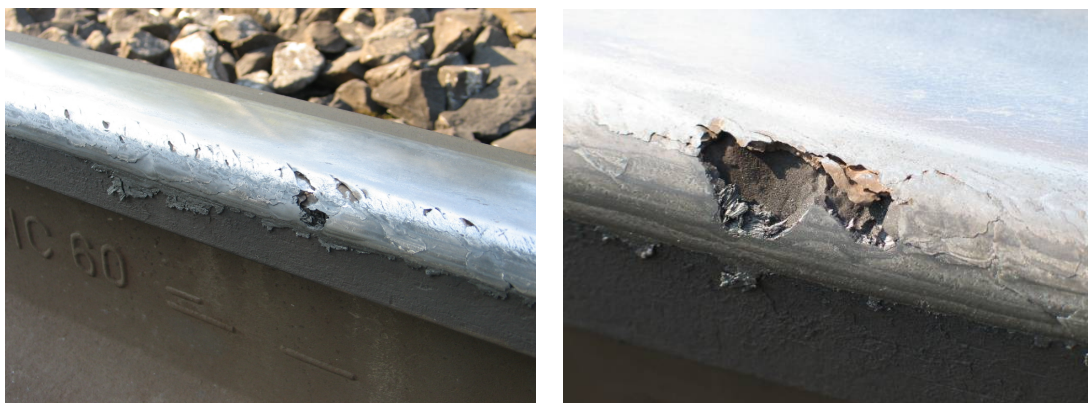
Figure 6: Extensive railhead damage shown by a heat-treated *premium rail* installed on the high rail in a track near Seebach Zurich. These rails were replaced with *VAR110* naturally hard rails.

Tests were made between Zurich Seebach and Regensdorf, where existing head hardened premium rails installed on Swiss railways (SBB) suffered extensive railhead damage as shown in Figure 6. A total of 486 m of *VAR110* rails were install in a reverse curve, including a short tangent section and the corresponding transitions. The minimum curve radius was 439 m, a value that justifies to make recourse to *premium rails* in order to limit as much as possible rail gage face wear. Line speed is 100 km/h and the traffic volume is around 8.5 MGT/year. As a result of the application on only one rail, part of the *VAR110* bars resulted to be installed on the low rail and part on the high rail.

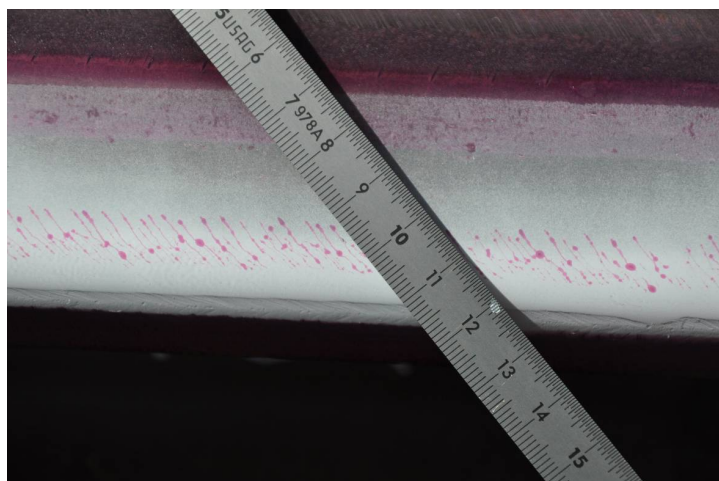
Figure 8: Head checks found on the *VAR110* rail during the last test (27.04.2012). High rail, running direction left to right.

Figure 8 shows the worst situation found on the *VAR110* rail 2.5 year after grinding. RCF appeared as approximately 45° inclined hairline cracks. This evidence was discussed in detail with SBB, which observed that “these head checks are very stable and visible only on the ending part of the curve” and concluded “very good behaviour of this *VAR110* rails”.

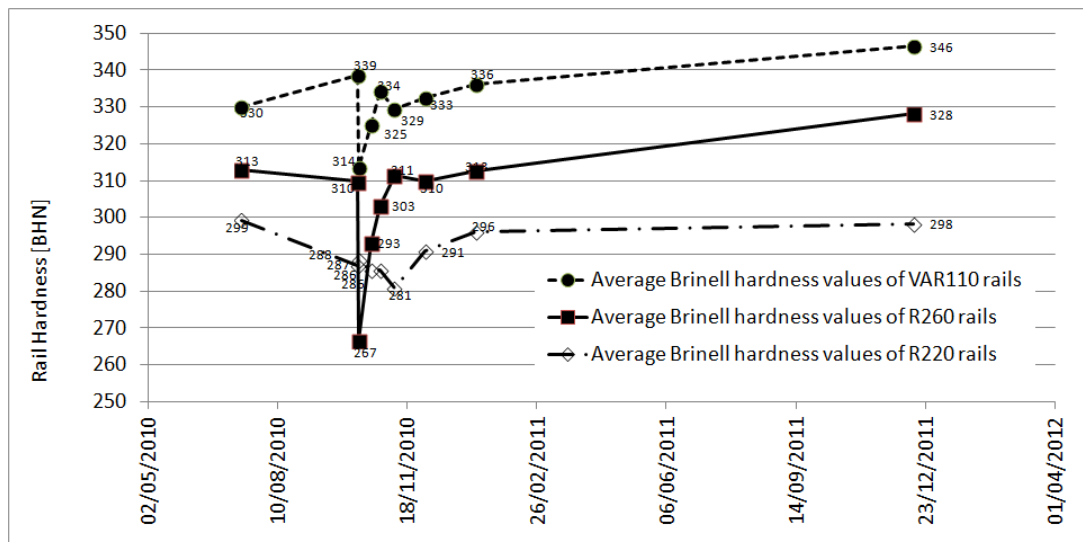
Figure 10: Rail hardness measured in Metronapoli network plotted vs. time.

The situation is summarised in Figure 10, showing how all the rail installed in the curves are affected by work hardening, even if in different proportion (R220= +78 BHN, R260= +68 BHN, VAR110= +16 BHN).
