WEAR AND RCF BEHAVIOUR OF CONVENTIONAL AND HARD RAILS IN DIFFERENT CONTEXTS

Prof. A. Bracciali, Dr. F. Piccioli, T. De Cicco

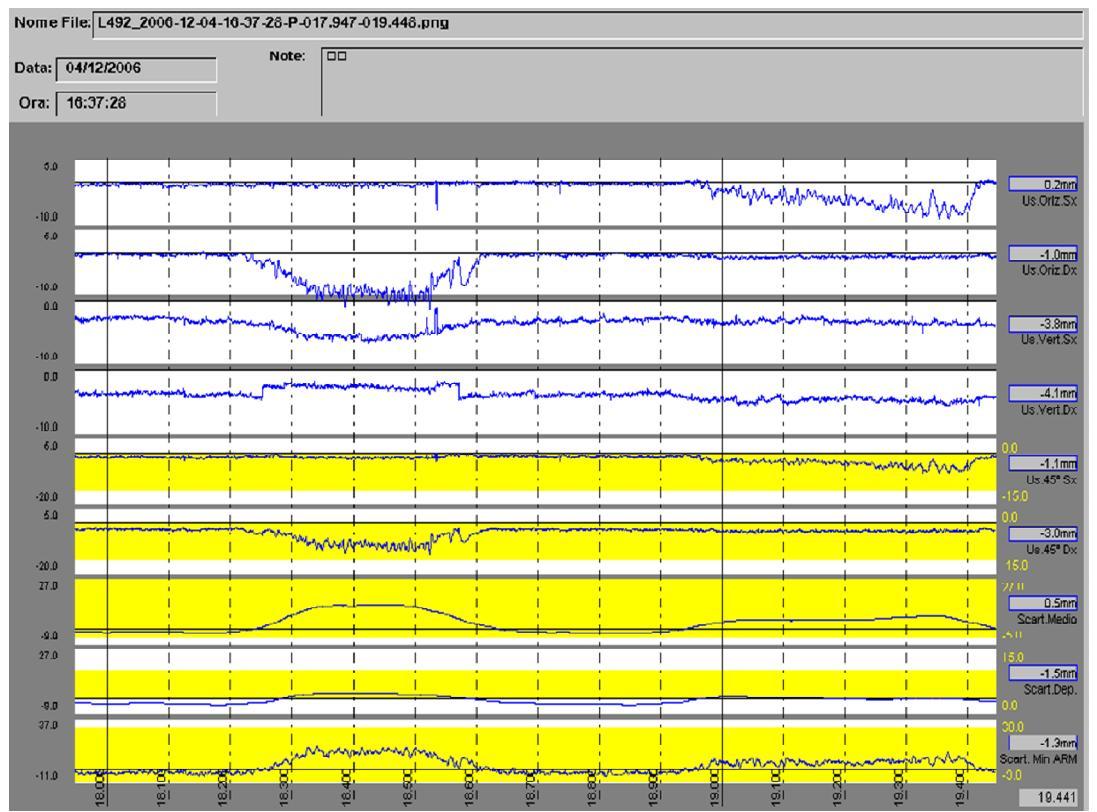
Figure 1. Typical screen dump of the output generated by *Archimede* software. Data of interest in this paper are wear at 45° on left and right rails (*Us.* 45° *Sx* and *Us.* 45° *Dx* respectively, i.e. the 5th and 6th diagram). "Us." is the shortened Italian word "usura" (=wear).

Data are stored on hard disk on the measuring train in a proprietary format and can be processed / printed for later use. A typical screenshot of some data recovered by the *Archimede* train software is shown in Figure 1.

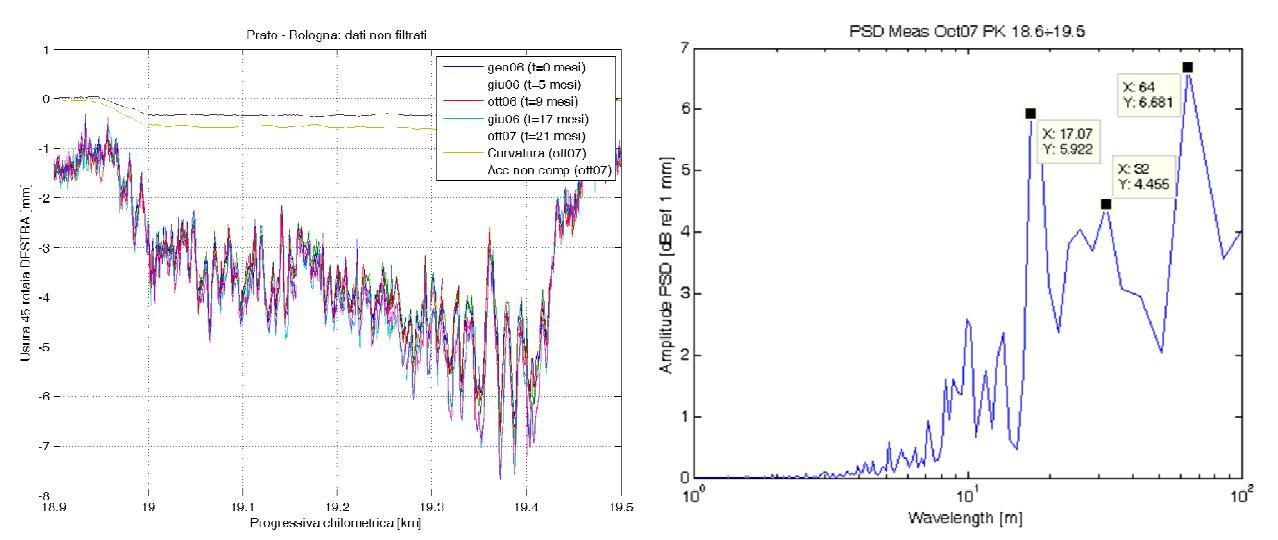
Figure 2. Rail wear at 45° on the right rail of the Prato-Bologna line around km 19.2 (left) and Power Spectral Density distribution, where peaks with higher energy content are highlighted (right).

Spectral analysis conducted on one set of data is shown in Figure 2, where peaks at 17.07 m, 32 m and 64 m are evident. Considering that resolution in the wavelength domain is inversely proportional to the wavelength (while it is constant in the spatial frequency – or wave number – domain), these peaks therefore contain the wavelengths of 18 m, 36 m and 72 m respectively. These lengths are characteristic

of 144 mm rails obtained by flash butt welding of 18 m and 36 m rails (a process that was usual before long rails of 108 m or 120 m were available on the market).

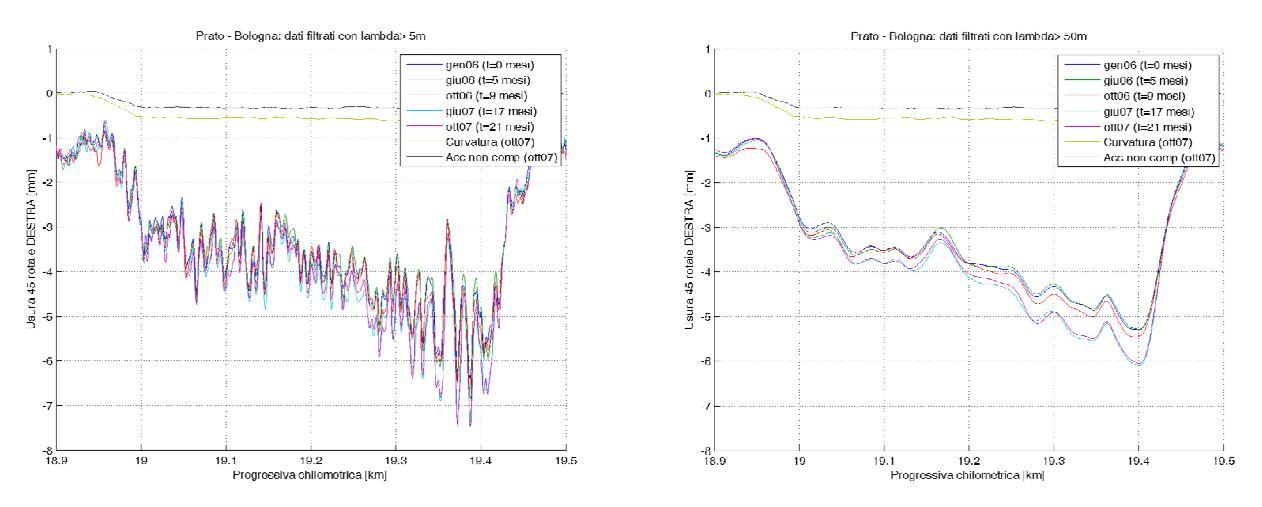
Figure 3. Space-domain data of 45° rail wear high-pass filtering wavelengths with cut-off wavelengths of 5 m (left) and 50 m (right).

In this work a non-causal filter, implemented in Matlab with the *filtfilt* command, was applied. This filtering procedure has the peculiarity that the order of the filter is doubled but that the phase shift is null for all frequency (or wavelength) components. This leads to preserving the relative angular position (phase) of all the signal components that can be superimposed in a straightforward way. Local space features are therefore affected as usual by the filter but without any further distortion. Figure 3 shows the effect of filtering with different cut-off wavelengths, respectively 5 m and 50 m. While in the first case filtering is mainly needed to remove local, extremely short phenomena (spikes), in the second case filtering returns a signal shape that is much more similar to *Archimede* printouts.

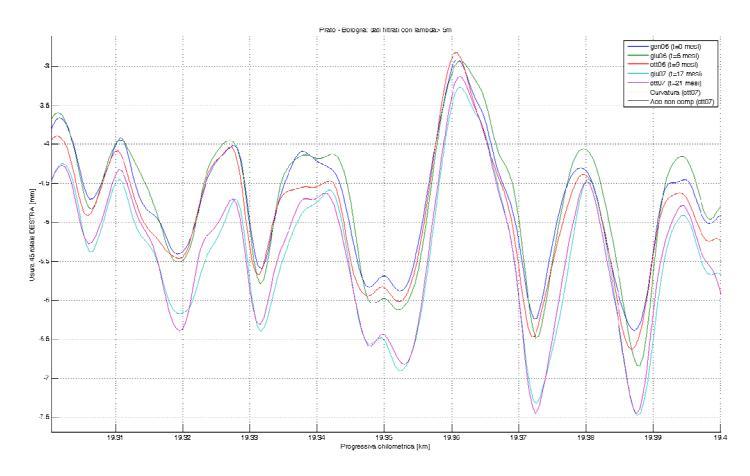
Figure 4. Zoom on the previous figure (filter cut-off wavelength=5 m). Variations of the wear at 45° in the order of 4÷5 mm over 10 m can be observed.

A quantification of the "lost" part of signal due to filtering can be done by simply zooming on the signal filtered above 5 m wavelength (Figure 4). It is clear how differences of $4\div5$ mm on a 10 m length basis are almost completely lost.

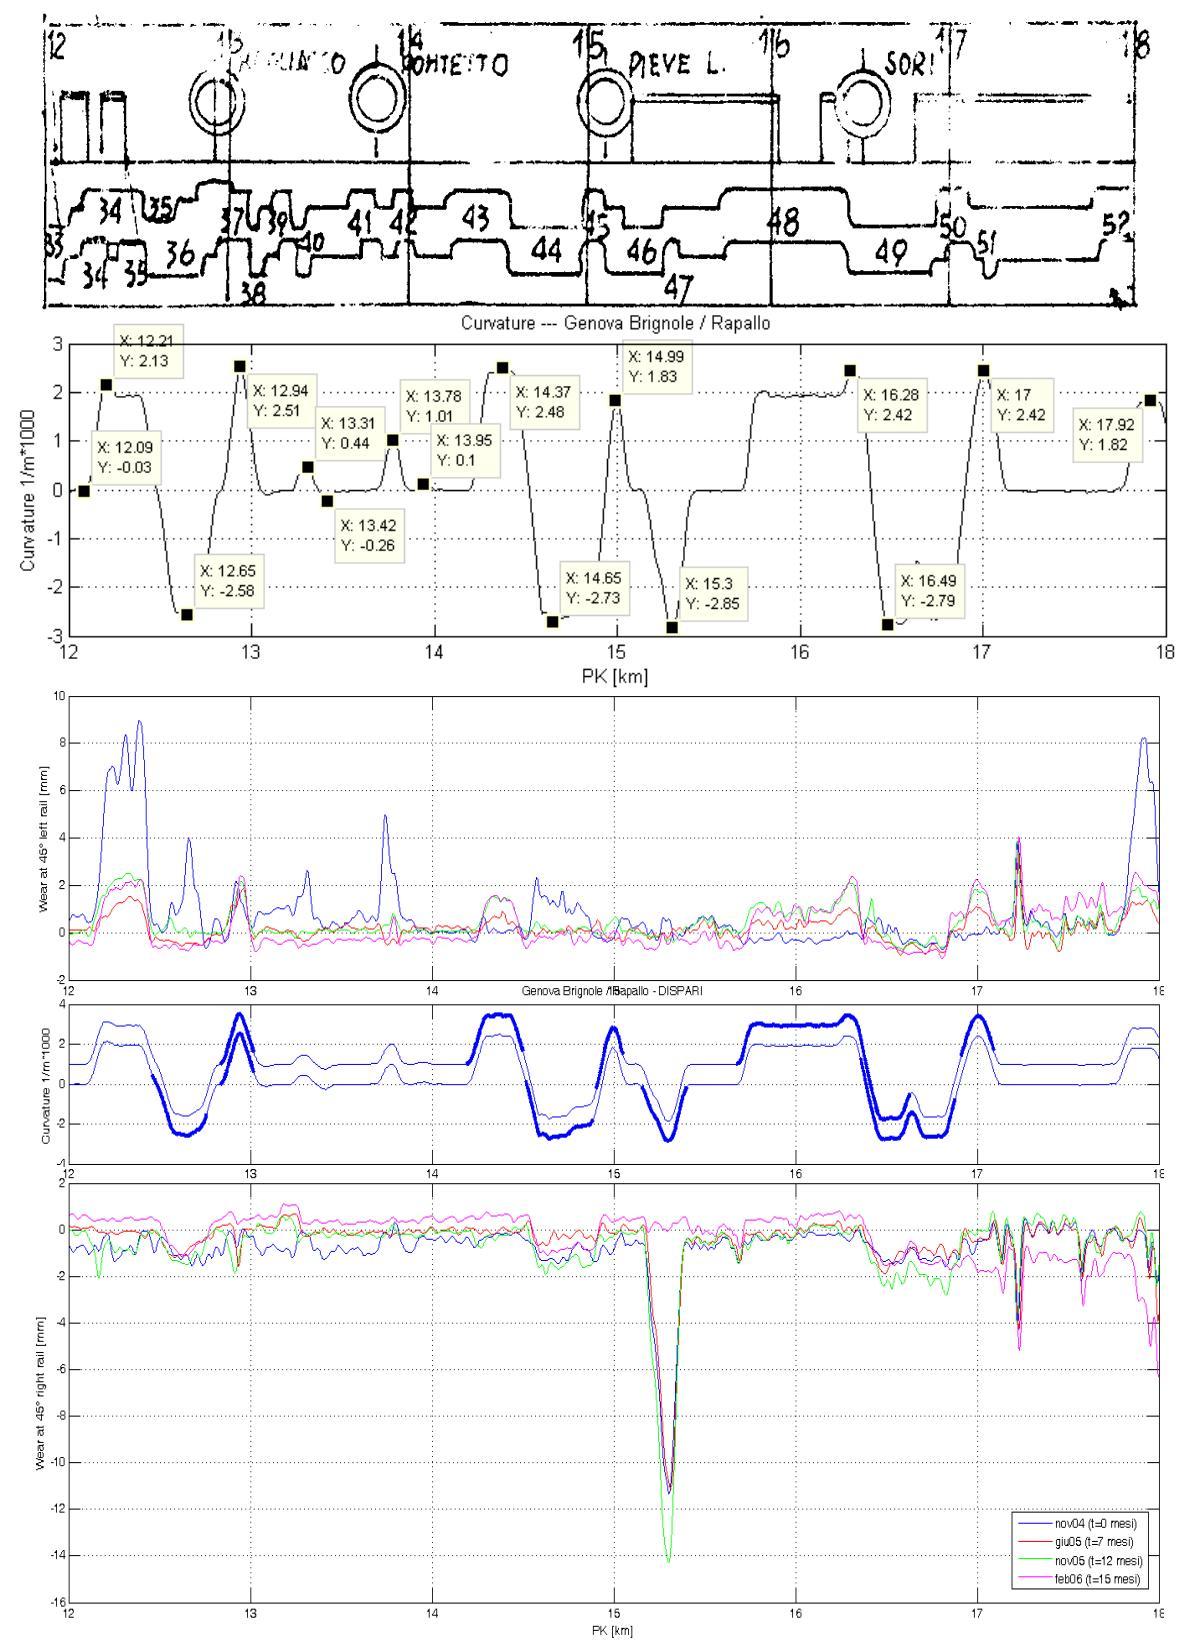
Figure 5. Example of data plotting for the Genova-Rapallo line. From top to bottom: curve numbering; *Archimede* curvature and PK measurement with indication of maximum curvature; left rail wear; track curvature (with indication of the position of hard rails); right rail wear.

Figure 5 shows as an example an excerpt of track and wear properties measured between PK 12+000 e 18+000. Rotating the page by 90° counter clockwise, it is possible to "see" the track as the virtual driver of a train. Location, curve severity and wear amplitude can then readily be observed.

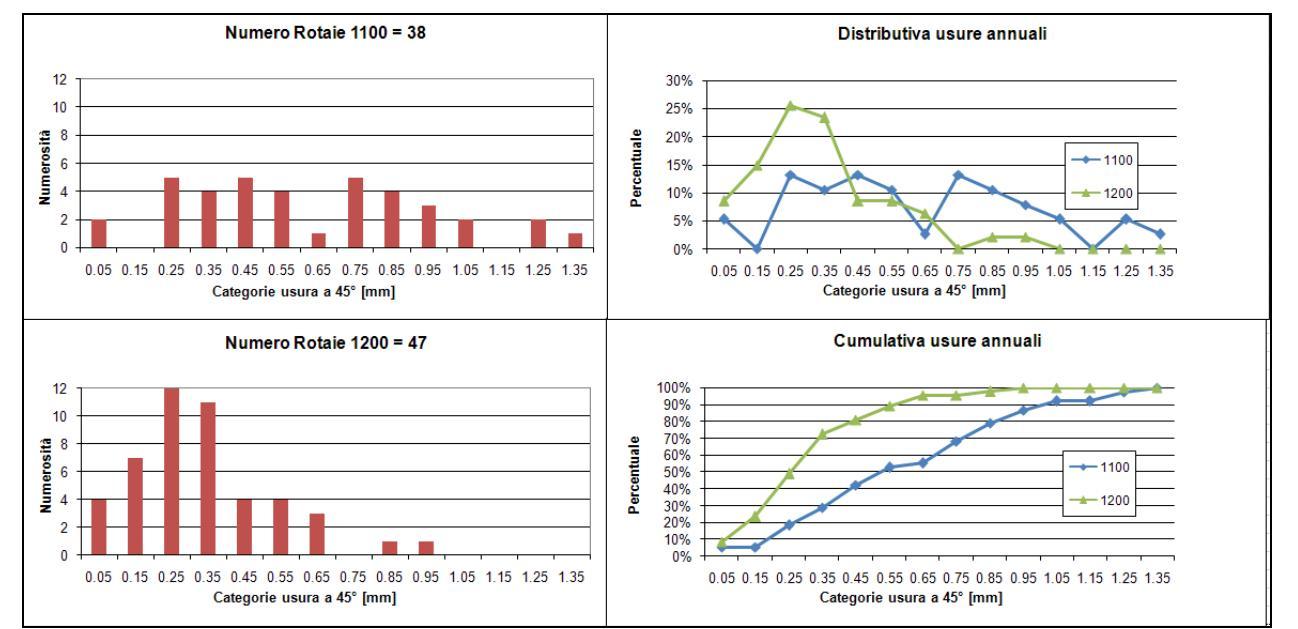
Figure 9. Genova-Rapallo: distributive and cumulative functions of average yearly wear rate for R320Cr (1100) and R350HT (1200) rails.

- wear distribution is much different for the two types of hard rails used, being mostly concentrate at low values for R350HT rails (more than 25% of occurrences in the class 0.2÷0.3 mm/year), while it is very dispersed for R320Cr rails (there are six values out of seven greater than 10% in range 0.2÷0.9 mm/year) (Figure 9 left);
- the cumulative diagram obviously reflects this distribution, having the 80% of R320Cr rails an average wear rate of 0.8÷0.9 mm/year vs. an average wear rate of 0.4÷0.5 mm/year of R350HT rails (ratio≈2) (Figure 9 bottom right);
- supposing, although not very likely, a constant wear rate and aiming at reach a useful life of 20 years before reaching the alarm limit w_{45} =14 mm (=0.7 mm/year), only 55% of R320Cr rails reach this goal compared to 96% of R350HT rails;

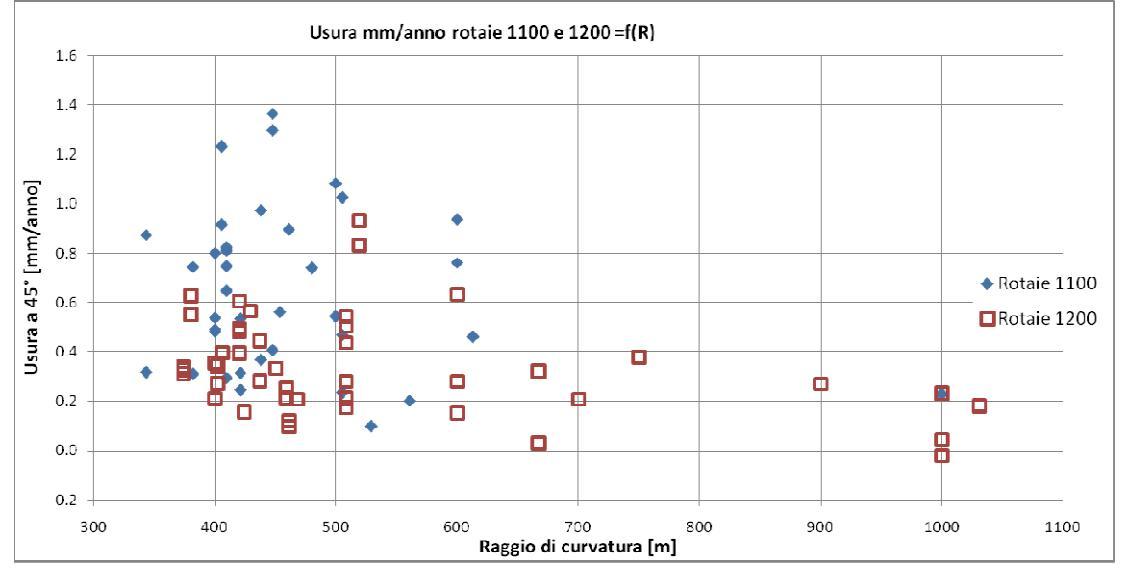
Figure 10. Genova-Rapallo: average yearly wear rate for R320Cr rails (38 measurements) and R350HT rails (47 measurements).

- apparently, there is not a simply relationship between the curve radius and average wear rate, as low wear rates were observed not only for large radii (as expected) but also for small radii (Figure 10);

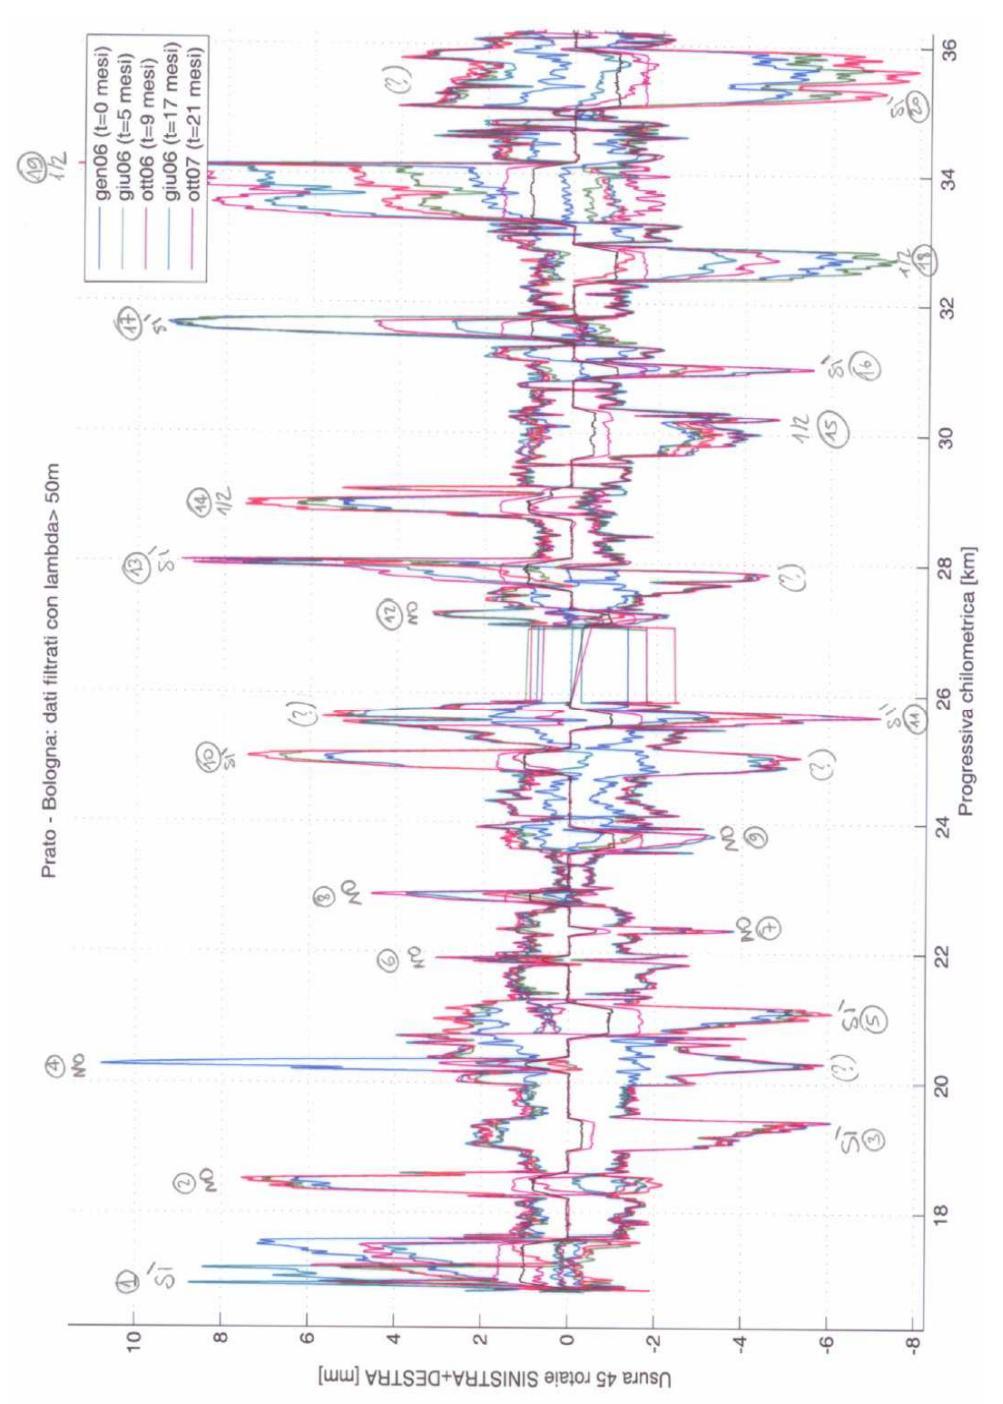
Figure 11. Prato-Bologna curves that suffer progressive wear indicated with SI' (=YES), 1/2 and NO depending on the presence of the phenomenon.

A recurrent behaviour was identified on a large portion of the curves, consisting of a progressive increase of w_{45} along the curve. This phenomenon applies in a more or less consistent way on all curves of sufficiently high length.

The extension of the phenomenon is such that transient effects due to vehicle dynamics after transition curve are believed to be completely exhausted, i.e. the phenomenon also happens in constant radius curve. As kinematic conditions are therefore stationary, the only possible reason for such progressive wear is linked to friction conditions, i.e. to variation of lubrication conditions. It seems that the train enters the curve with well lubricated locomotive wheel flanges (no trackside lubricators are active) and then that the protection offered by the lubricant is gradually lost. A global overview of this phenomenon is shown in Figure 11, and one of the curves shown there (i.e. curve 3) was already shown in Figure 2.

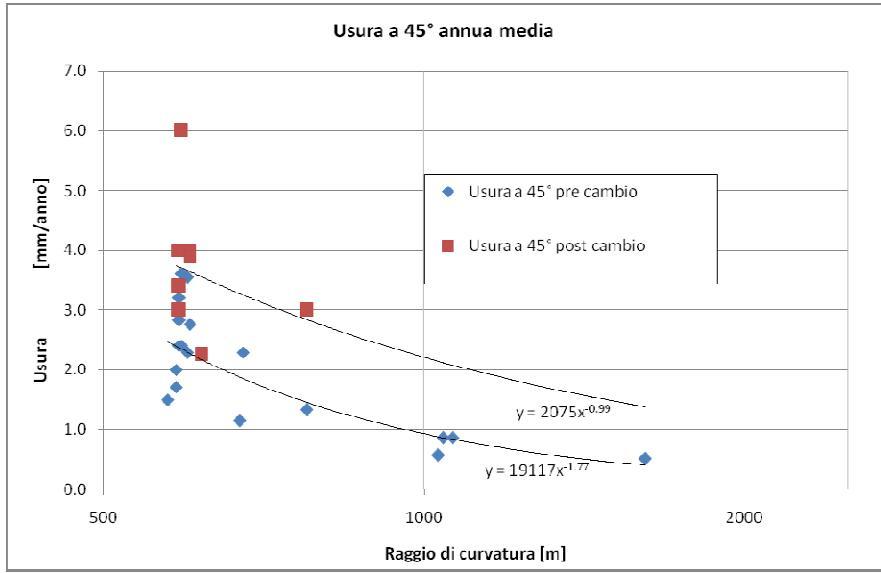
Figure 15. Prato-Bologna: average yearly wear rate [mm/year] pre- and post-rail change vs. curve radius.

Wear rate appears to be, in this case, inversely proportional to a fractional power of curve radius. Figure 15 shows the trend of average yearly wear rate (where needed considering pre- and post-rail change).

It is evident how rail change leads to a sudden increase in the average yearly wear rate of rails, always resulting in the $3\div 6$ mm/year range, at least until wear rate are not restored to values typical of partly worn rails where forces are distributed over a large contact surface. It may be interesting to observe that

there are three curves that before rail change had moderate or negligible wear and that after have shown severe wear. These were curve 17 (R=602 m, w_{45} =4 mm/year), curve 2 (R=775 m, w_{45} =3 mm/year) and curve 4 (R=617 m, w_{45} =2.3 mm/year), although for the last only one pre-rail change measurement was available (and then it has not been possible to estimate pre-rail change wear rate).
