Paper 28

Vibrations in Signalling Equipment: Limitations and Improvements of Current Standards

A. Bracciali, F. Piccioli and L. Di Benedetto Dipartimento di Meccanica e Tecnologie Industruali Università di Firenze, Italy

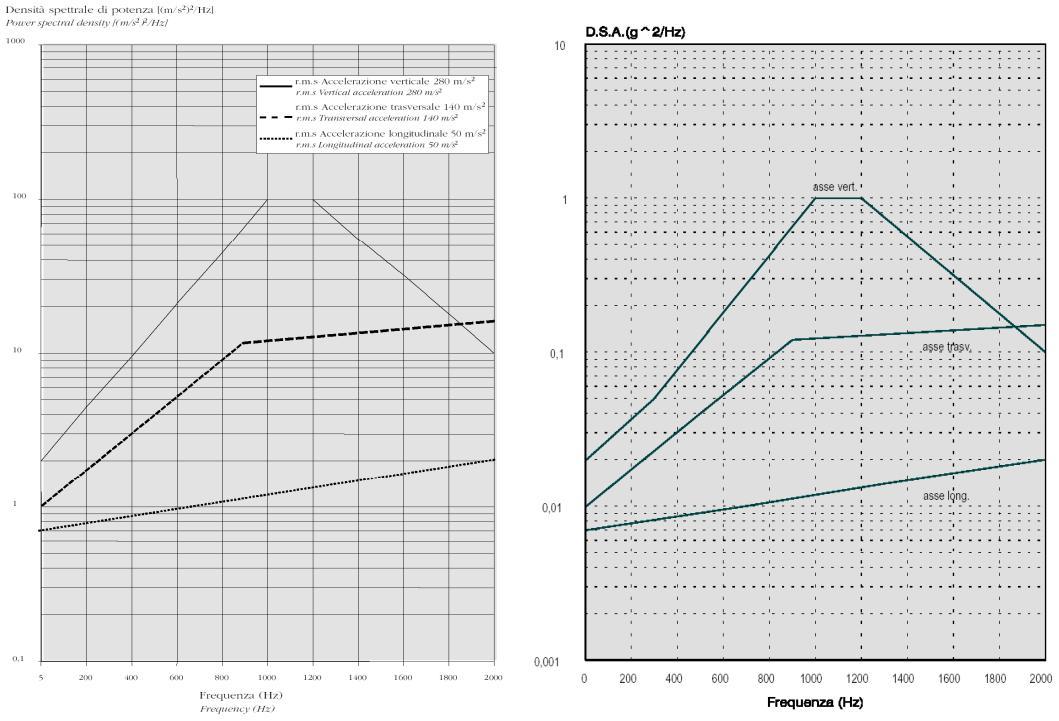
Figure 1. Comparison of power spectral densities for random testing (excerpt from [1] and [3])

About vibration spectra, Figure 1 compares [1] and [3] showing that the standards are more or less equivalent in terms of amplitudes and frequencies.

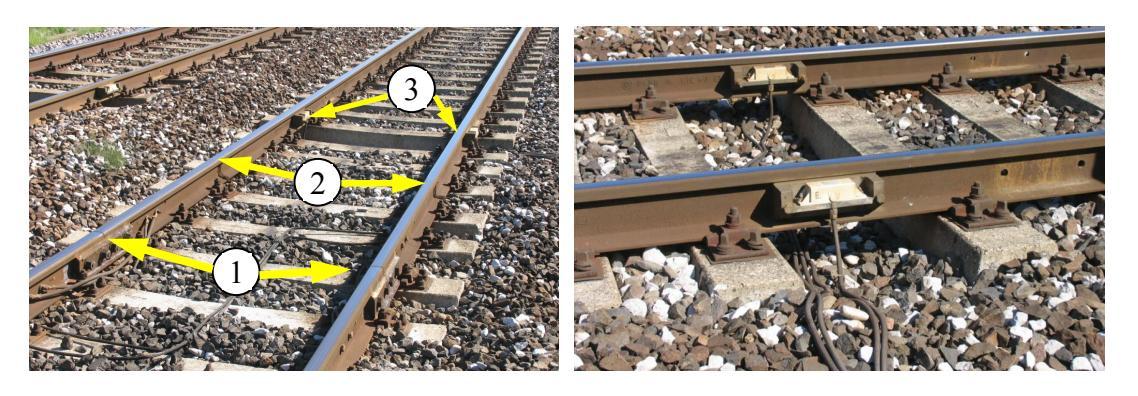
Figure 2. Track under test general view (left, 1=insulated rail joint, 2=aluminothermic weld, 3=treadle) and close-up on the treadles (right)

Figure 2 shows the details of the site which resulted critical for the treadles for several reasons. First of all, the function of the treadle is to count the axles in an axle counter signalling application, where track circuits are normally used to interact with signals, and in fact the classic installation of insulated rail joints (IRJ) is visible. In Italy, IRJs are prepared in the workshop with rail crops of different length that are therefore welded on the field with the aluminothermic welding process. This environment is potentially harmful for the WD as impacts with the welds and the IRJ may lead to abnormal stresses.

The situation is complicated by the specific relative positioning of the WD on the left and the right rail. In order to be able to determine not only the pass-by of an axle but also the running direction, the treadles must be separated by a certain distance which, for ultra-low floor wagons that run in that line since a few months, forced the infrastructure owner to further separate the sleepers where the WD are mounted. This resulted in an abnormally wide sleeper bay and in a possible lack of tamping. Rubber sleeper pad where also missing or displaced as a result of trackworks to get this particular arrangement.

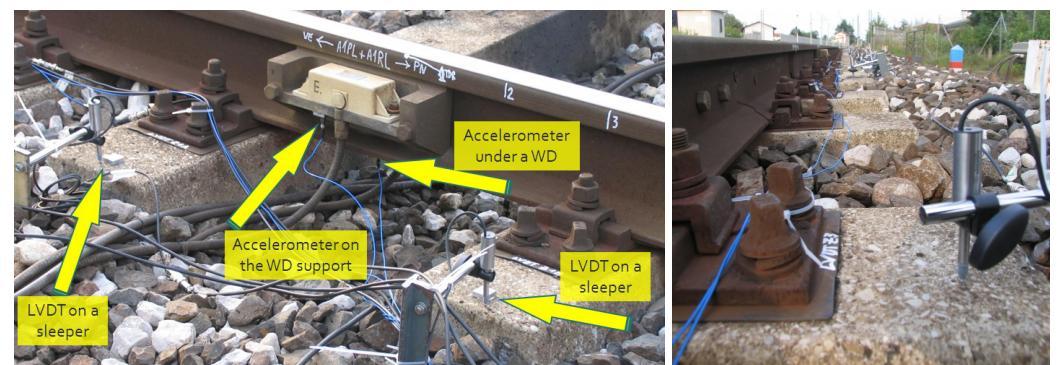
Figure 3. Overview of the sensors in the area of one WD (left) and detail on a LVDT displacement sensor mounted on a sleeper

The measuring chain included displacement and acceleration transducers, according to the following scheme (see Figure 3):

- sleeper acceleration and vertical deflections were measured near the WDs, welds and IRJs;
- accelerometers were measured under the rail foot at WD, welds and IRJ locations;
- accelerometers were mounted also directly on the WDs;
- further measurements were performed at about 20 m from the treadle (so-called "standard track").

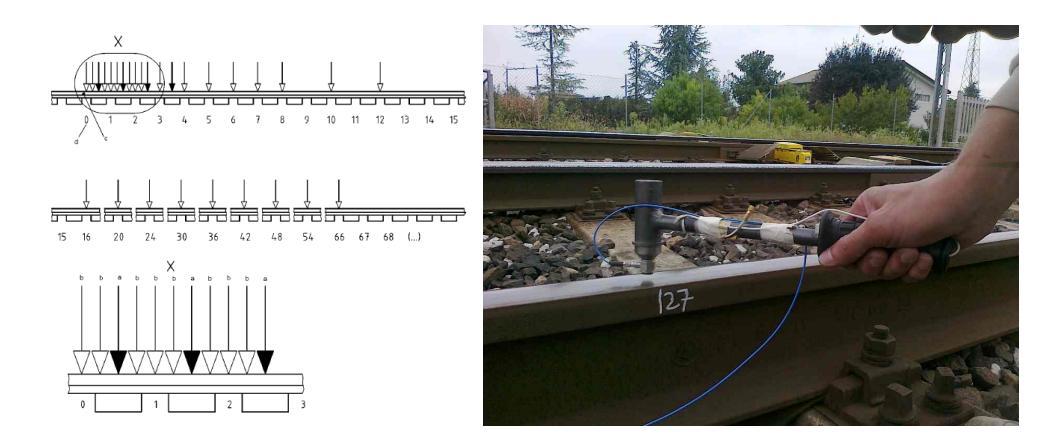
Figure 4. To estimate TDR, track is excited vertically in a number of locations (left) by using a roving instrumented hammer (right) and an accelerometer mounted under measuring point 0 (not shown)

TDR is an important indicator in external noise evaluation as the contribution of the noise emitted by the rail can be important in case the decay is insufficient. In this work the concept is extended to understand how impacts can reach the WDs. Data acquisition and processing to estimate TDR are detailed in [6], to which the reader is referred for more information. Figure 4 describes the rationale of the test.

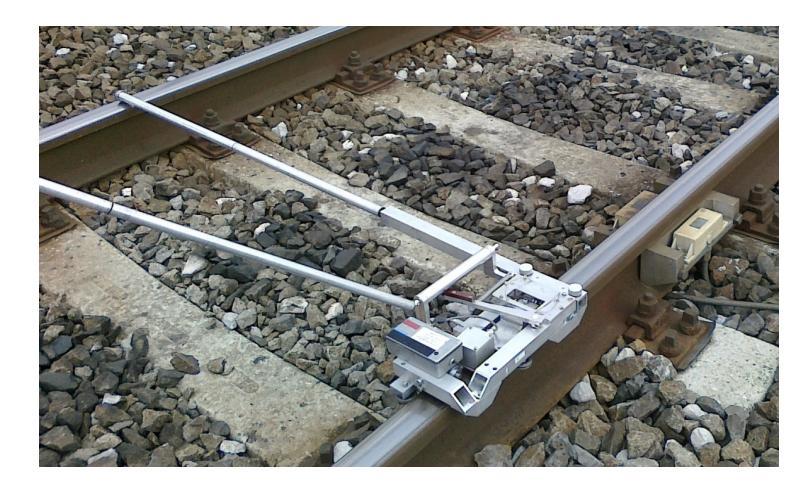
Figure 5. The trolley (CAT, <u>www.railmeasurement.com</u>) used to perform roughness measurements. The trolley proved to be incompatible with the regular functioning of the treadle, as it is counted as a passing by wheel

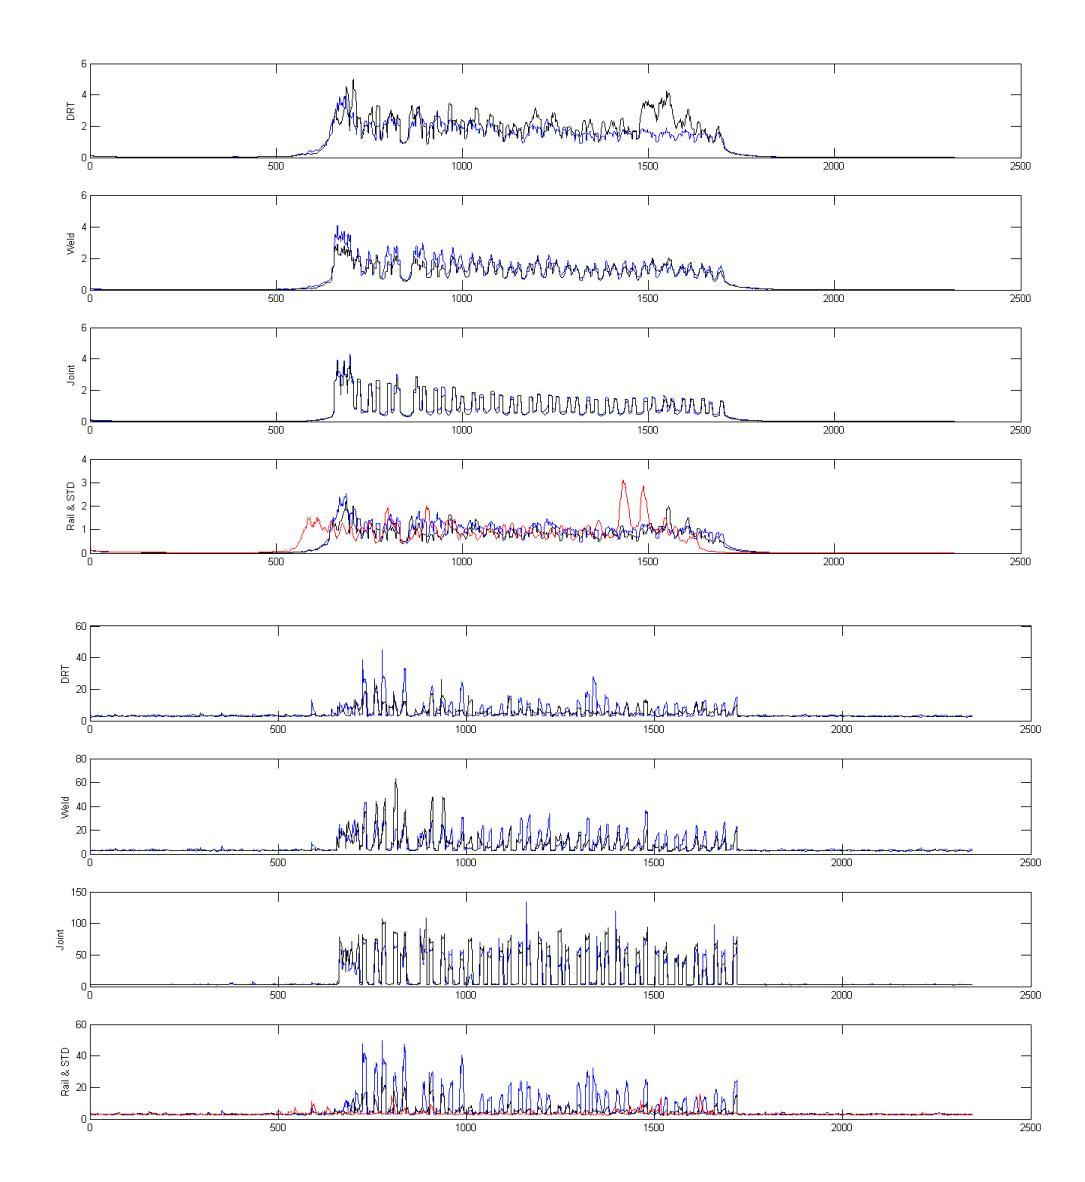
Figure 6. RMS (upper) and kurtosis (lower) for train t902 (freight at 106 km/h)

For <u>train t902</u>, a freight train with tread braked wheels running at 106 km/h, the difference in terms of RMS between all the elements of the track, and in particular between rails feet under WDs and rail foot under the "standard track", are quite small (Figure 6). Energy levels are quite high due to the speed and the high roughness of the wheel treads. The difference between the same elements in terms of kurtosis is instead quite large, indicating that even if the vibration energy is almost the same, the number and the relevance of the shocks is very different. The presence of a high number of shocks near the WDs area is due to the presence of welds and joints, while the absence of high kurtosis levels on the "standard track" suggests that no wheel flats are present.

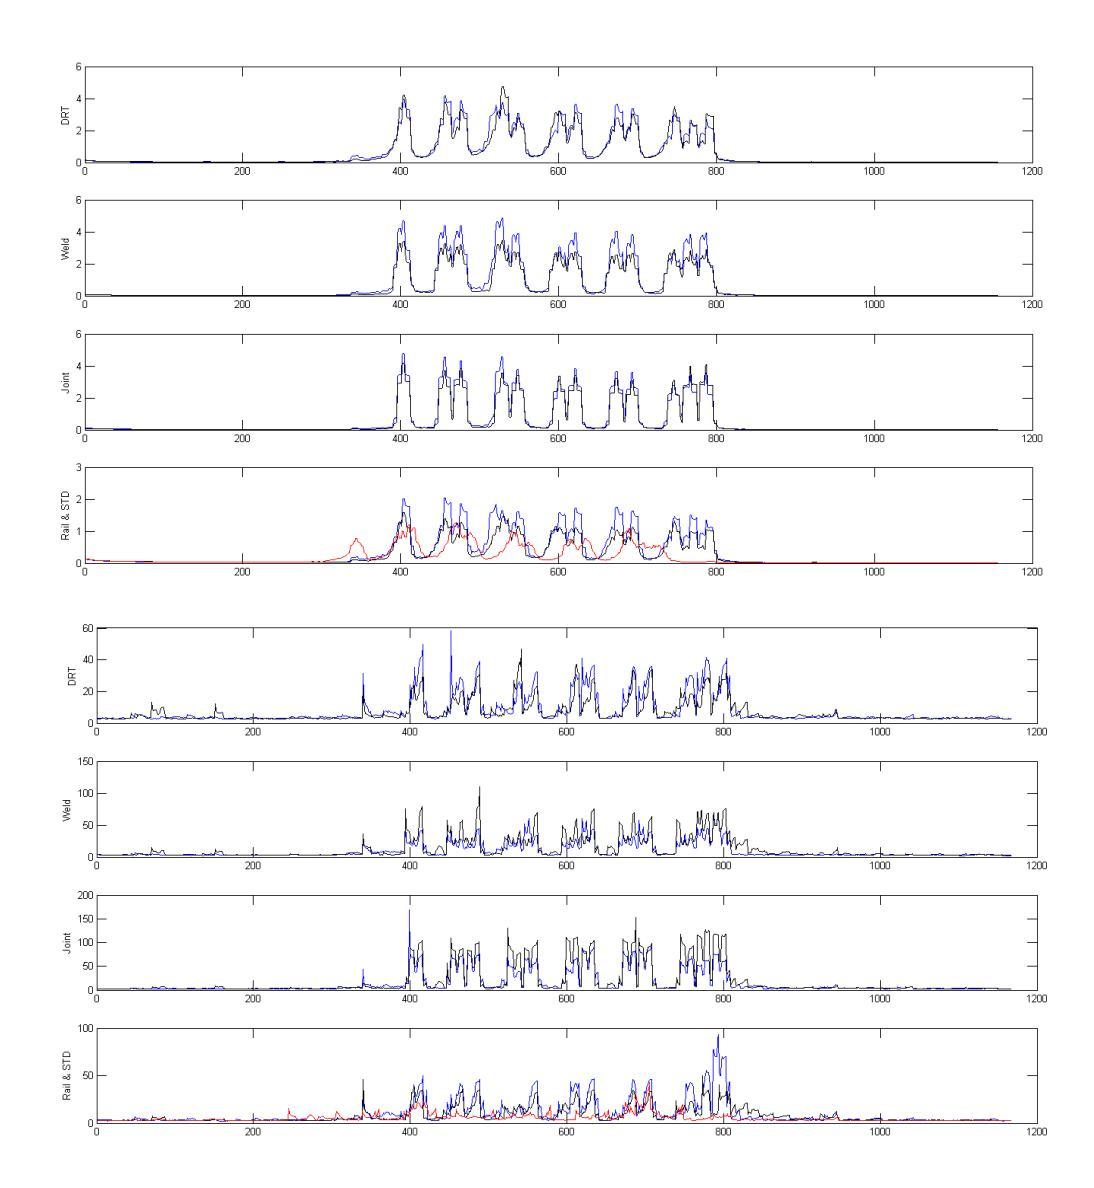
Figure 7. RMS (upper) and kurtosis (lower) for train t928 (regional at 129 km/h).

For <u>train t928</u>, a regional train with disc braked wheelsets running at 129 km/h, the difference in RMS level is just a bit larger between the rails, but differences in the kurtosis indicator are much smaller than in the previous case (Figure 7).

This behaviour is believed to be related to presence of wheel flats. In this case shocks are present in all rail sections (also in the "standard track" rail) resulting in a relatively small difference in the kurtosis indicator. Nevertheless in the WDs area both wheels flats, welds and joint peaks are present, partially explaining the difference in energy.

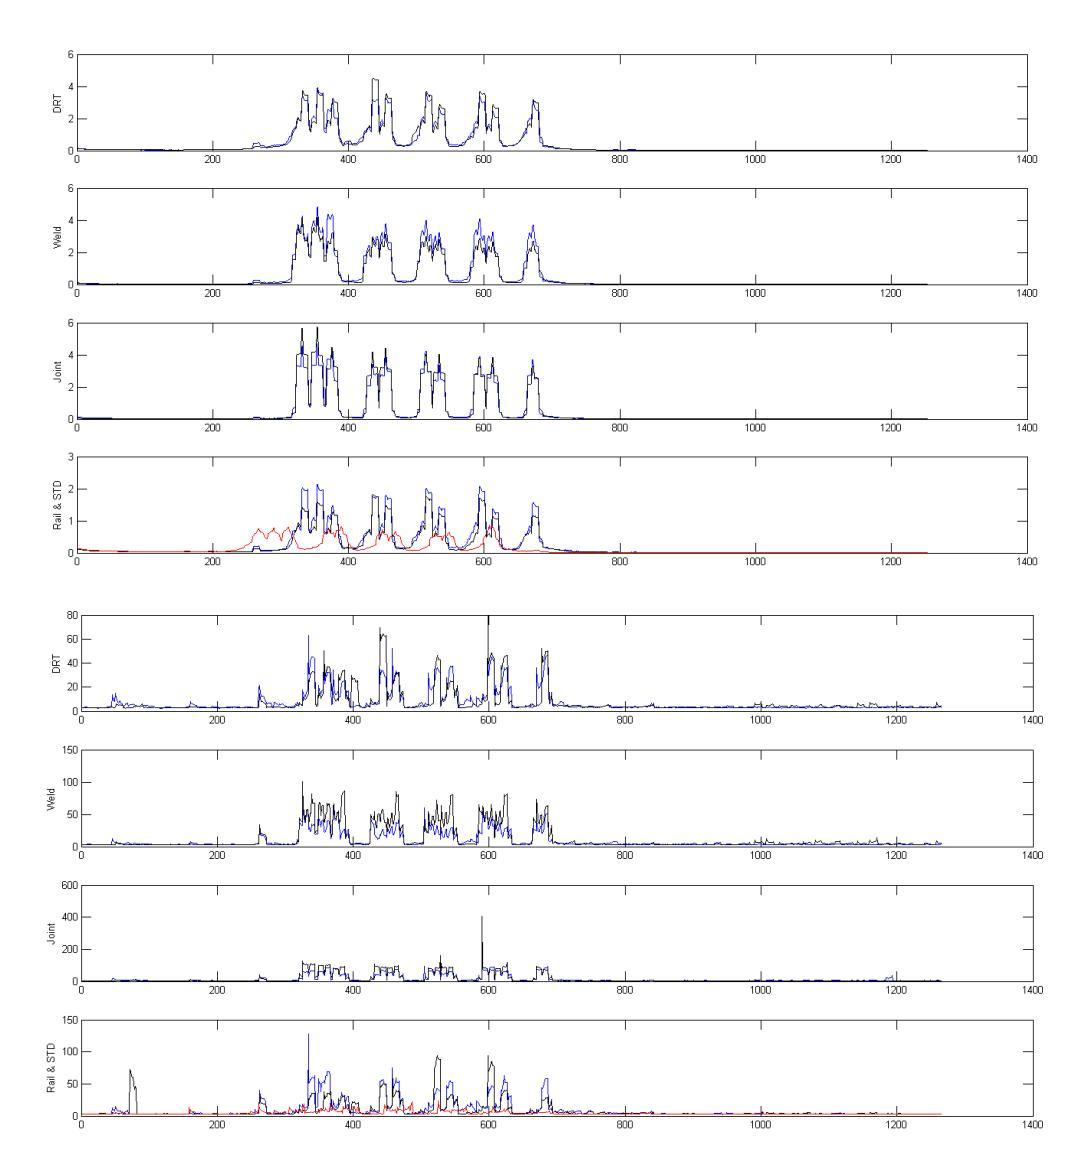
Figure 8. RMS (upper) and kurtosis (lower) for train t947 (120 km/h). Traces represent for each case, from top to bottom: WDs, welds, joints, rails + standard track rail

<u>Train t947</u>, a regional train with rolling stock similar to the previous example and running at 120 km/h regional train, shows a non negligible difference in RMS levels together with evident differences in the values of kurtosis. In case rolling stock was probably not affected by wheel flats and the shocks are evident only in the WDs area due to the presence of welds and joints. (Figure 8).

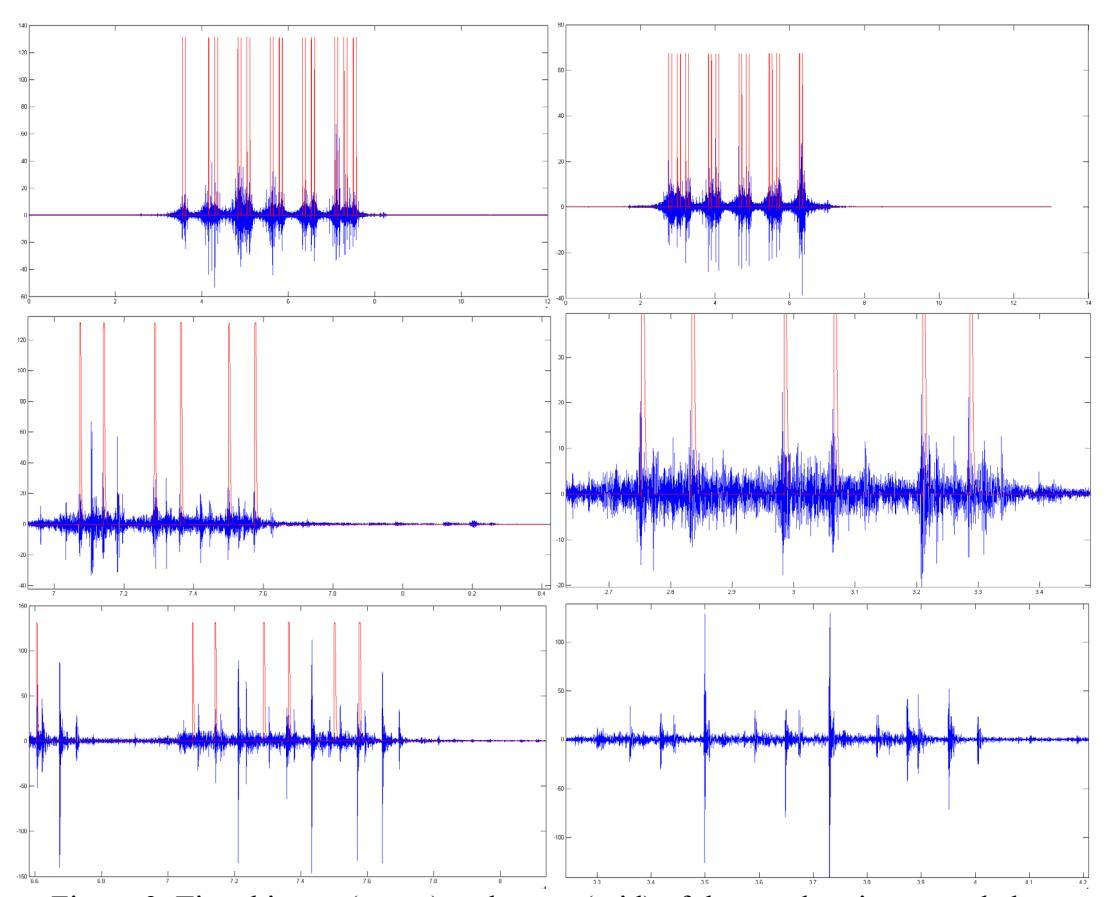
Figure 9. Time history (upper) and zoom (mid) of the acceleration recorded on "standard track" for train t928 (left) and train t947 (right). Portion of the acceleration recorded on right rail foot under WD (lower) for the same trains

Time histories show (Figure 9) substantial differences between the two trains signals that can be summarised as follows:

train t928 shows high peaks (amplitude up to 700 m/s²) in the "standard track" area, while train t947 shows instead much lower accelerations (up to 250 m/s²);

- peaks in the "standard track" area are not synchronized with wheels (red lines) for train t928, indicating the presence of wheels flats, while higher acceleration levels in the "standard track" for train t947 are instead synchronized with wheels, indicating this levels as the result of the normal rolling of a disc braked wheel;
- looking at the acceleration recorded on right rail foot under the WD, train t928 shows further peaks not synchronized with wheels, that are due the combination of the impacts given by interaction of the wheel with IRJs, welds and the presence of wheel flats, while for train t947 less non-synchronized peaks appear (as there are no wheel flats) that are related only to the interaction of the wheel with IRJs and welds.

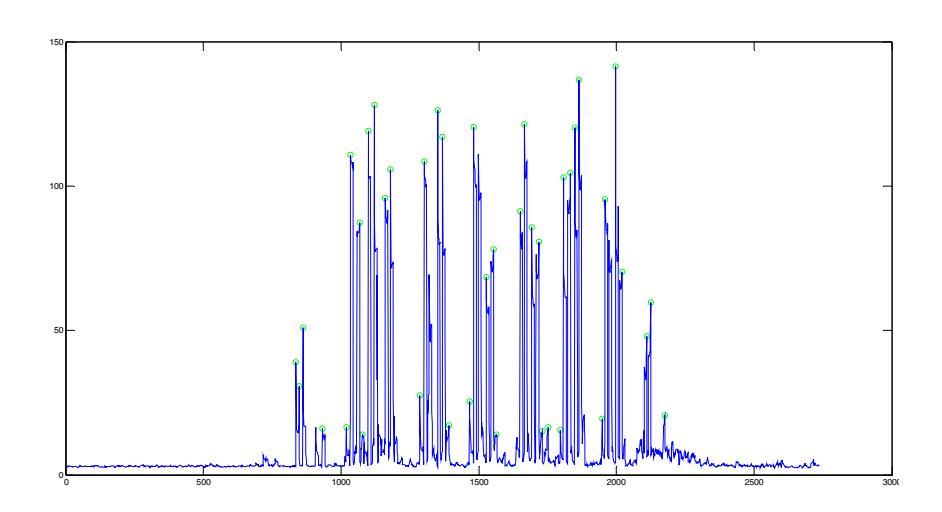
Figure 10. Peaks extraction procedure example: kurtosis values calculated for the accelerations recorded on the right IRJ for train t908

Each train data set was then subjected to both RMS and kurtosis statistical analysis of peaks. In each signal peaks were first automatically identified by a specific procedure (an example is shown in Figure 10), then peaks for each channel were classified and a frequency distribution of values was obtained.

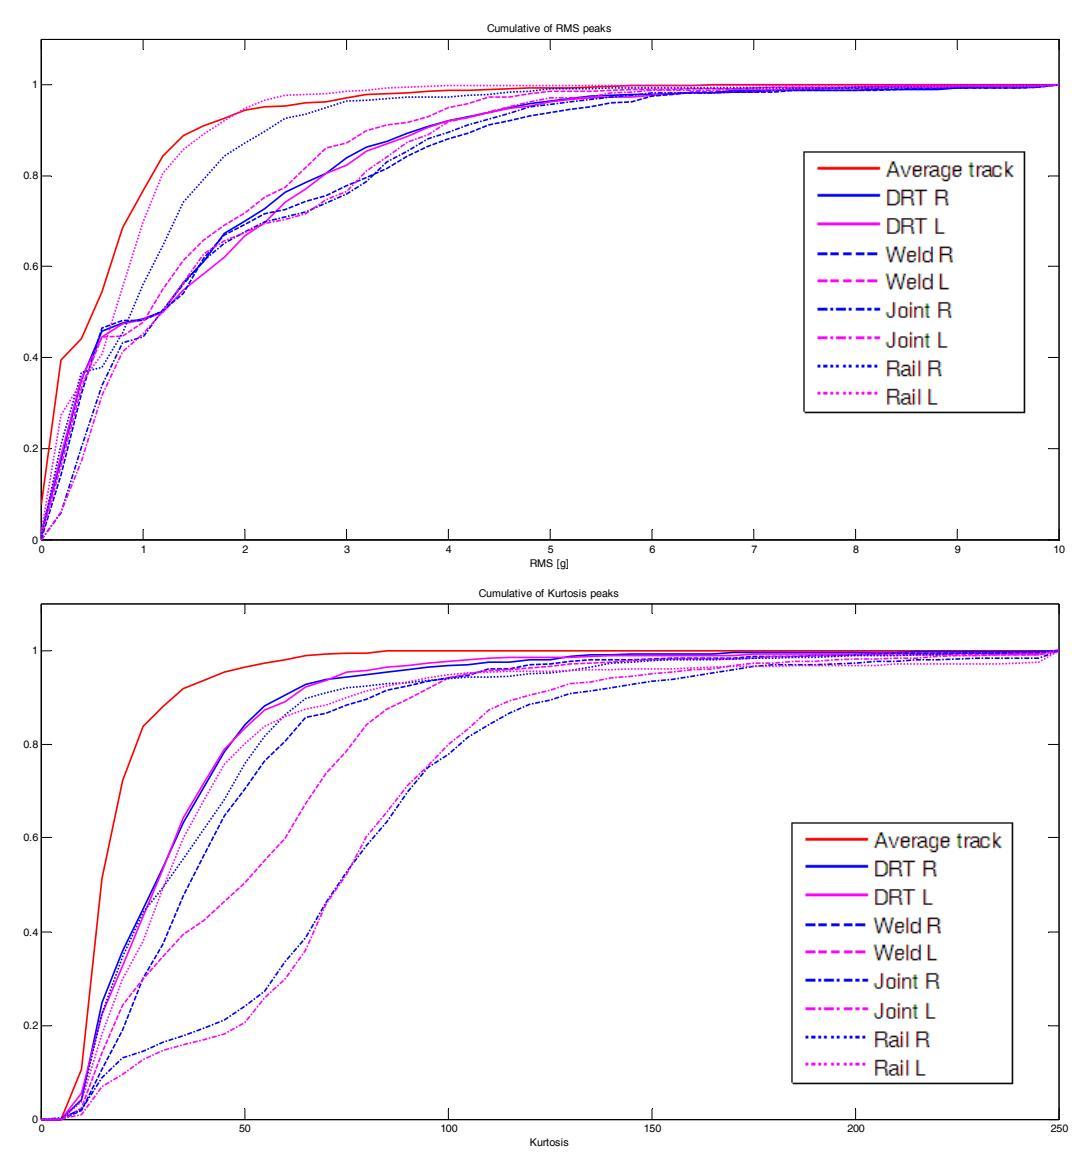
Figure 11. RMS (upper, in g units) and kurtosis (lower) cumulative curve of occurrences for all trains

Cumulative distributions were calculated by means of numerical integration of the distribution histograms. Figure 11 shows the RMS and kurtosis cumulative curves for all trains measured during the measuring campaign, where the bigger differences between track elements are visible in the kurtosis curves, while the behaviour of RMS curves is less "definite" especially in the case of joints, welds and WDs.

The physical interpretation of this curves is that the difference in stress for the different track elements is not related to energy (vibrations) but instead in term of influence of the peaks (shocks) on the signal.

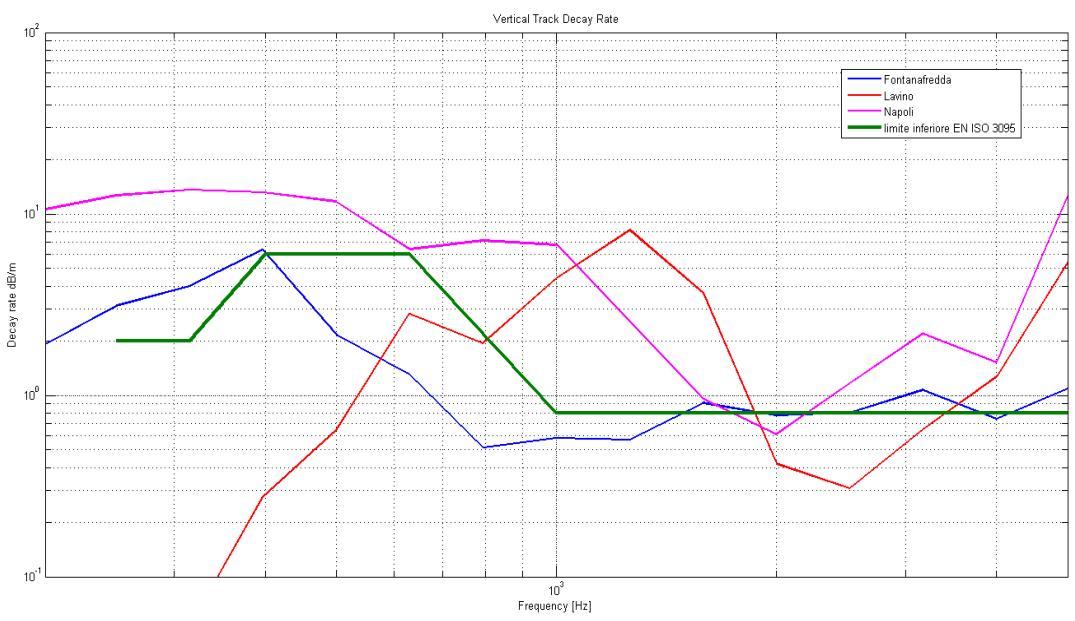
Figure 12. Vertical track decay rate for three different tracks: present ballasted track (blue trace), comparison ballasted track (red trace), slab track (magenta line). Green thick line is the lower limit in TSI HS RS for noise type tests purposes[12]

The estimated vertical TDR is shown in Figure 12 together with the TDR measured in two other sites and the following main differences can be observed:

- slab track is much more damped (high decay rate) than ballasted track in all the frequency range;
- the comparison ballasted track is more damped than present campaign track from around 500 Hz to around 1100 Hz (both track generally exhibit lower damping than the slab track);
- the present track has a particularly low damping (around 0.6 dB/m) in a quite wide frequency (800 to 1200 Hz approximately).

Even considering all the limits of this particular application of the TDR procedure, it is quite evident that the low damping of the present track leads to a much easier vibration propagation along the rails. As an example, to reduce of 50% (=-6 dB) the vibration at around 1 kHz it is necessary to move by approximately 10 m from the excitation position.

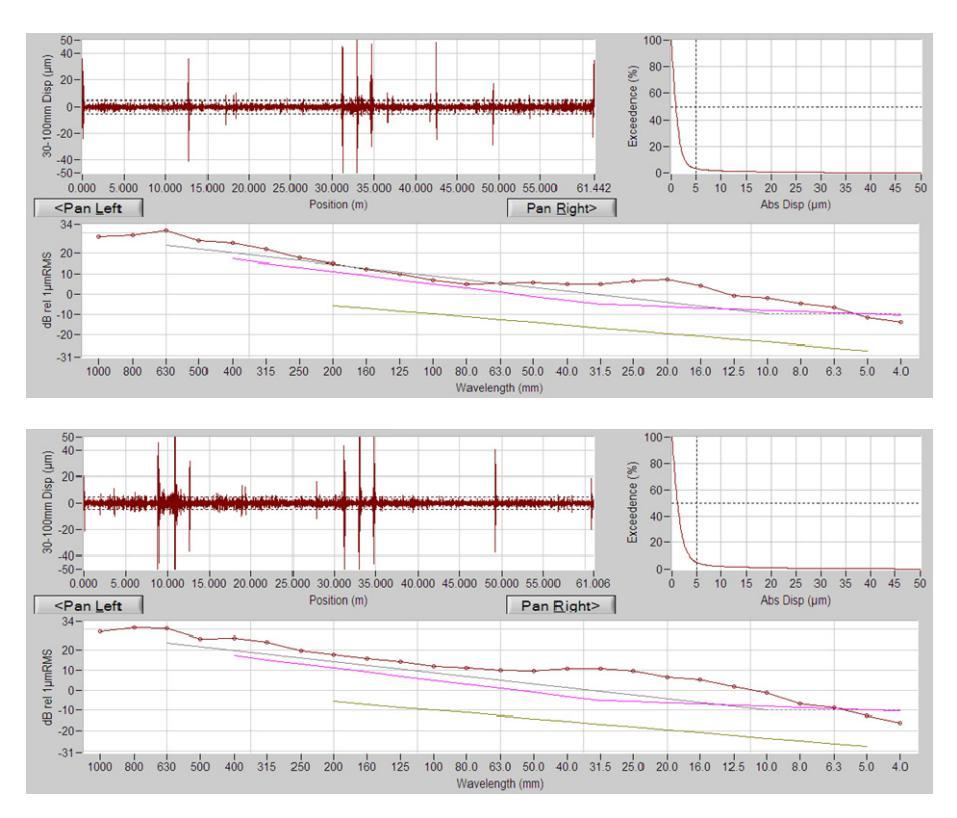
Figure 13. Roughness measured in the 30÷100 mm wavelength range for left (upper) and lower (right) rails. Peaks due to rail welds and insulated rail joints are clearly visible

The measurements, longer than 60 m, included all the irregularities (welded and insulated rail joints) and were filtered in the 30÷100 mm wavelength range that is particularly meaningful, being the typical range were rail corrugation is mostly likely to happen. It resulted that the railhead surface is in good longitudinal conditions (Figure 13). It can be concluded that the excitation due to the wheel-rail contact far from local defects.

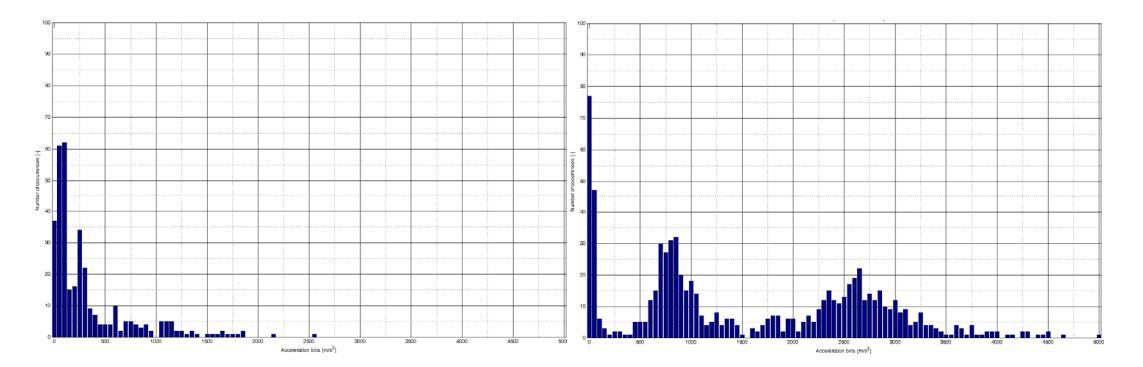
Figure 14. Number of peaks in 50 m/s² bins for the standard track and IRJ02 measuring points

All the channels were subjected to such procedure. As some representative example, Figure 14 and Figure 15 show the number of peaks for all trains on the "standard track", in correspondence of an IRJ and directly on the WD.

Although the number of samples is too low to draw firm conclusions, is evident that the number of events of high amplitude is not negligible, especially where their presence is logical (e.g. on insulated rail joints). The WD is subjected, even for such a short measuring campaign, to a quite high number of spikes bigger than 2500 m/s².

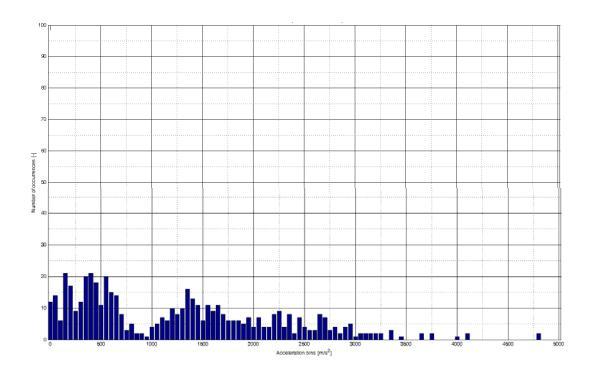
Figure 15. Number of peaks in 50 m/s² bins for WD01 measuring point
